Sinking of US Cargo Vessel SS *El Faro*  
Atlantic Ocean, Northeast of Acklins and Crooked Island,  
Bahamas  
October 1, 2015

**Accident Report**

NTSB/MAR-17/01  
PB2018-100342

# Marine Accident Report

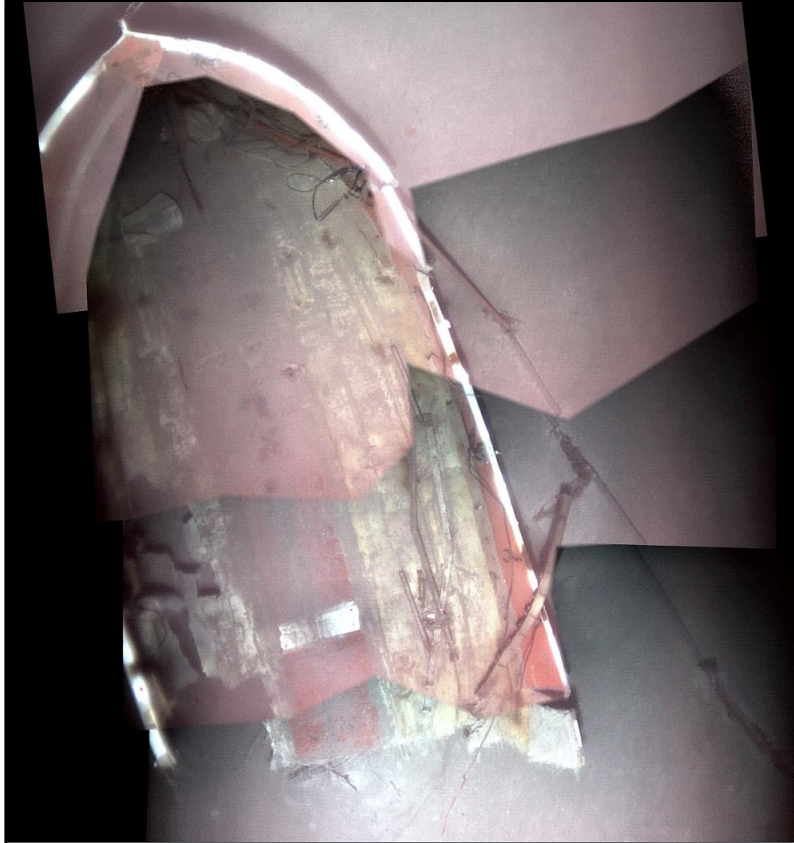
**Figure 24.** Photomosaic of *El Faro's* port lifeboat from images taken during second search mission. Bench seats and other internals are missing. Reflective tape on top of gunwales is illuminated.

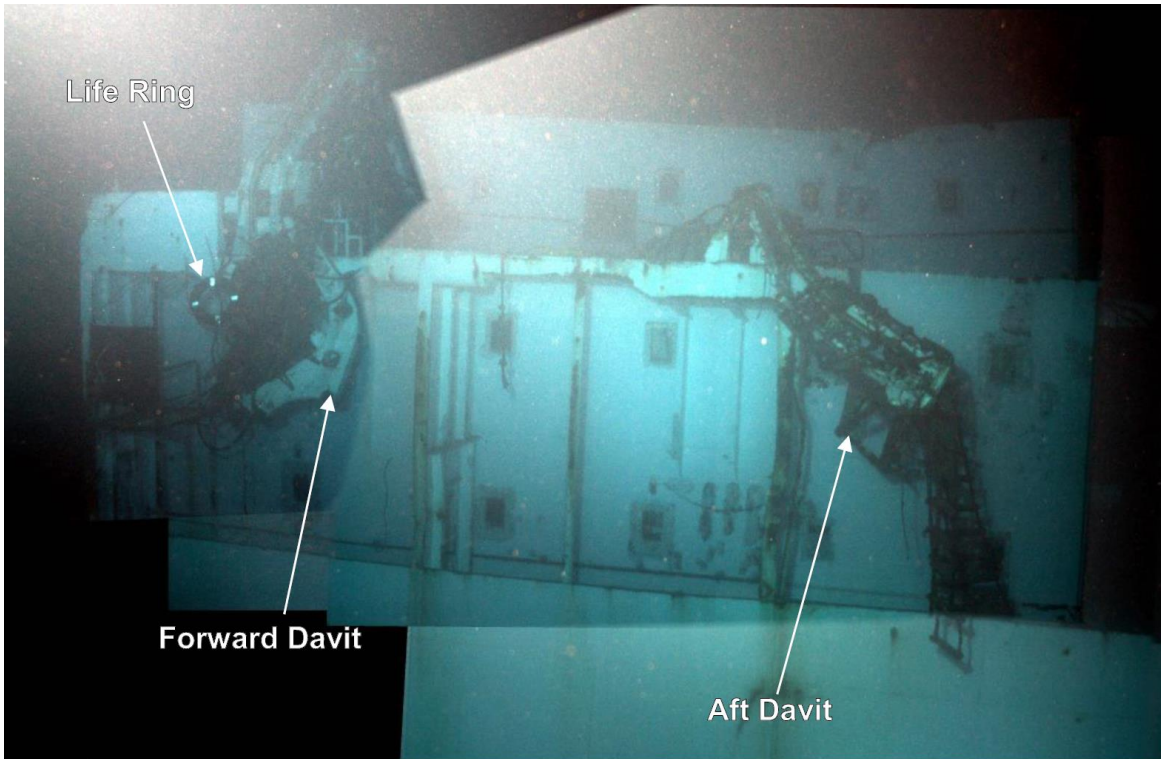
**Figure 26.** Gravity davits for port lifeboat, showing forward davit in place but damaged and aft davit broken and dangling. (Photomosaic image from mission 2)

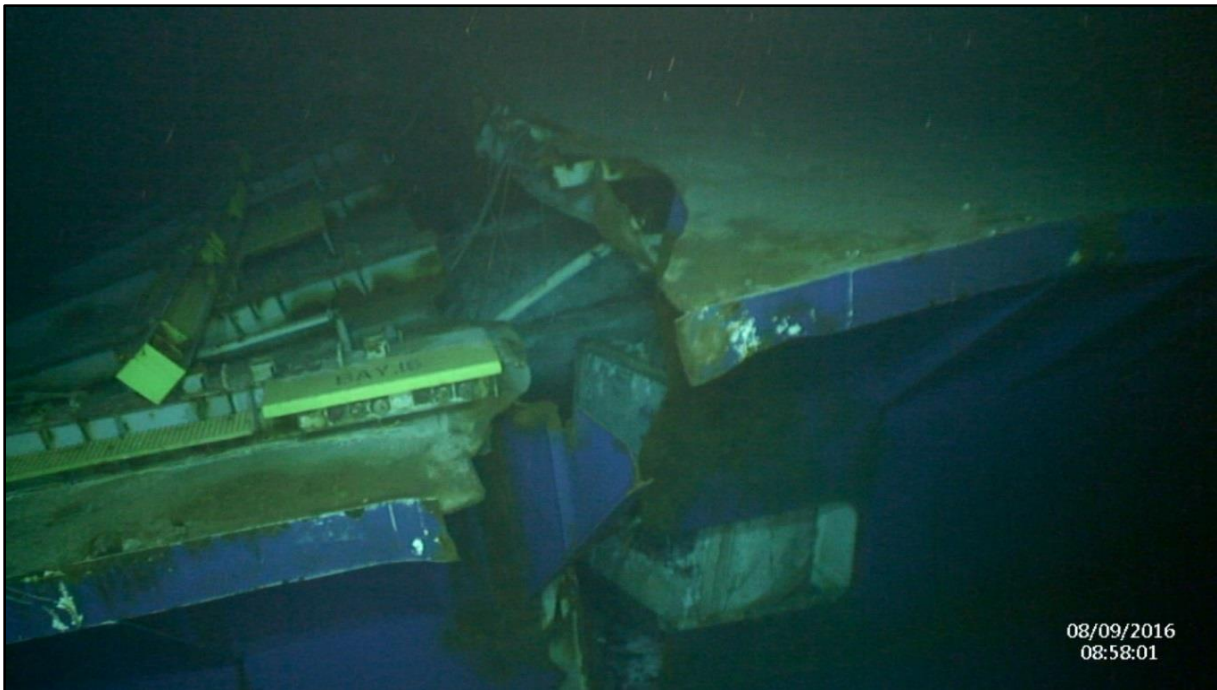
**Figure 30.** Hull fracture in starboard sideshell and across main deck at container bay 16, forward of frame 200. (Image from mission 3)

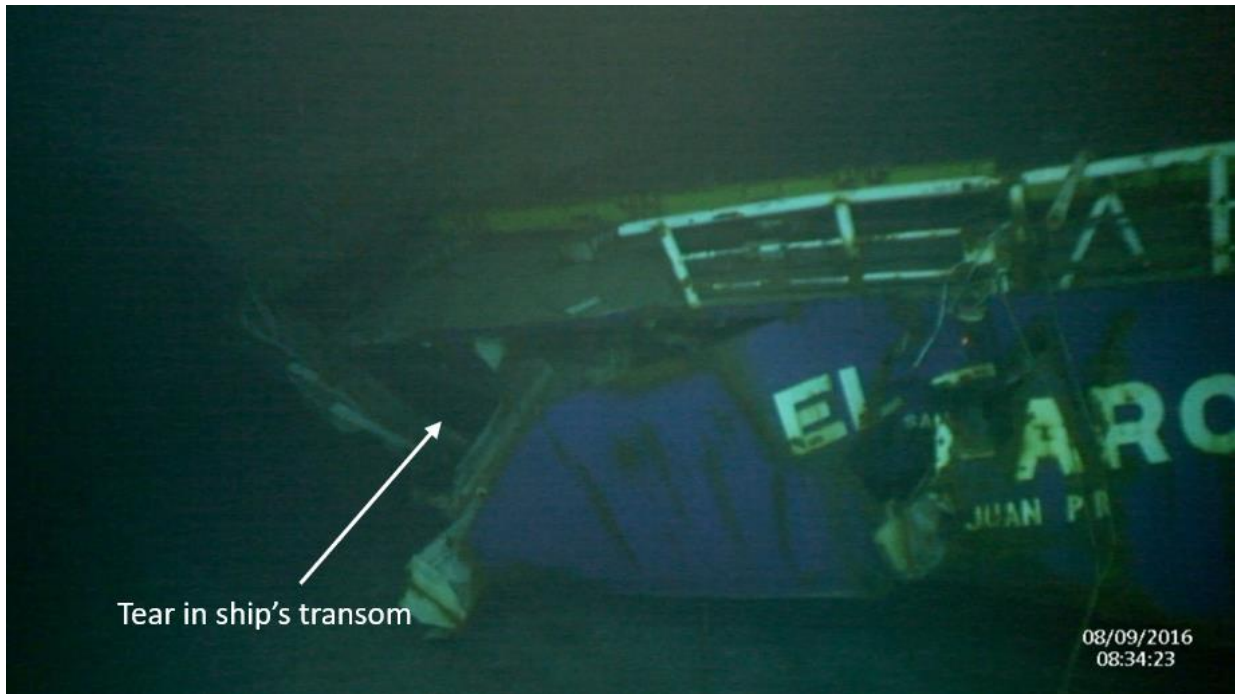
**Figure 31.** Tear in ship's transom. (Image from mission 3)

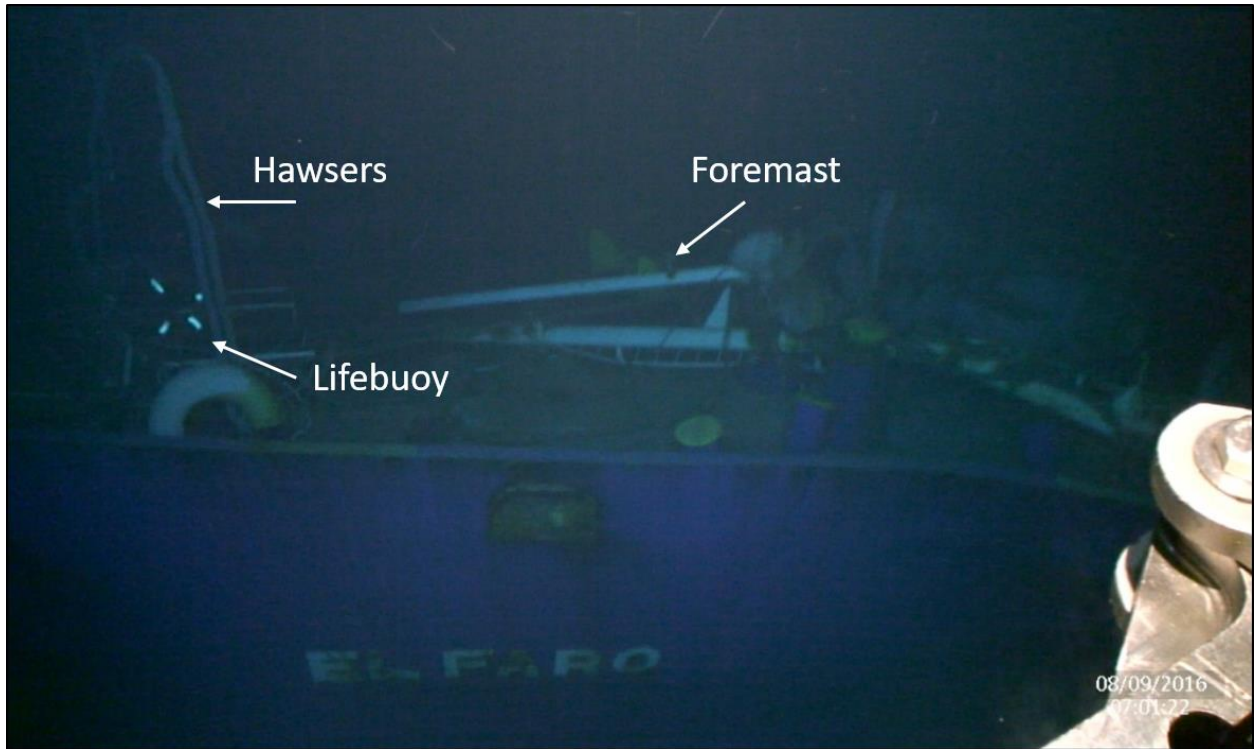
**Figure 32.** Foremast toppled on port side of bow; reflection is from lifebuoy on railing next to hawsers. (Image from mission 3)

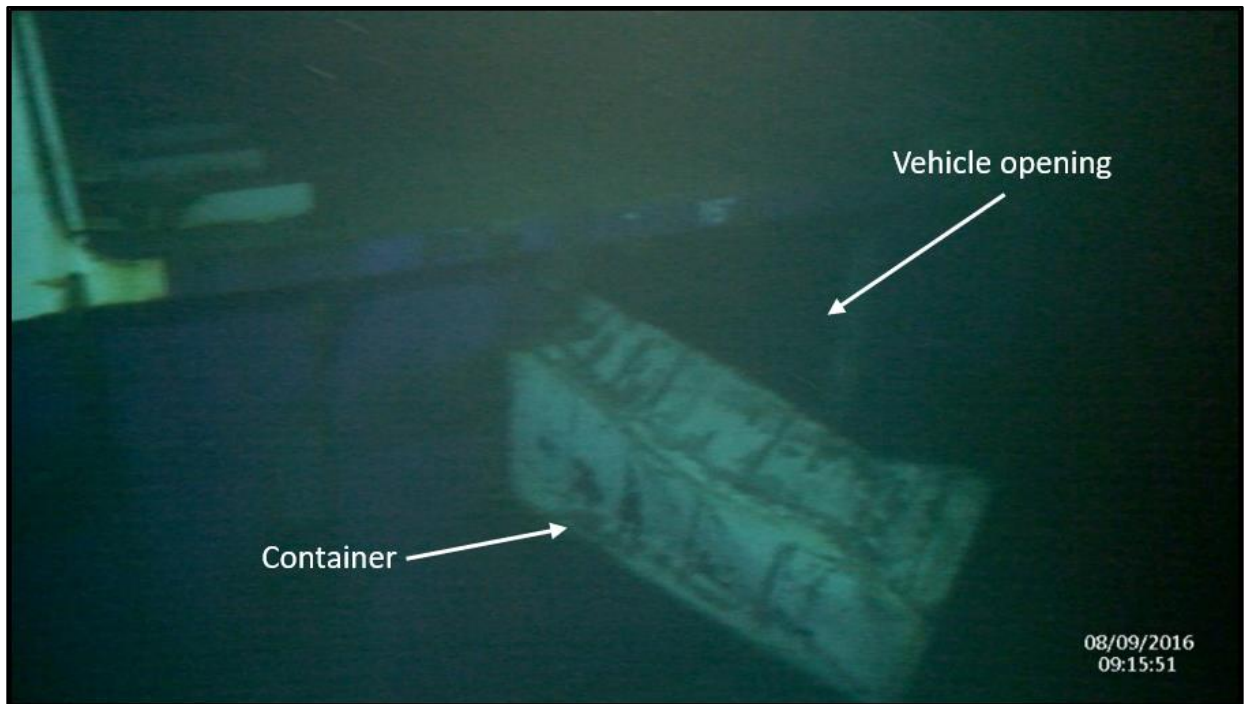
**Figure 33.** Container protruding through vehicle opening in bay 15, starboard side. (Image from mission 3)

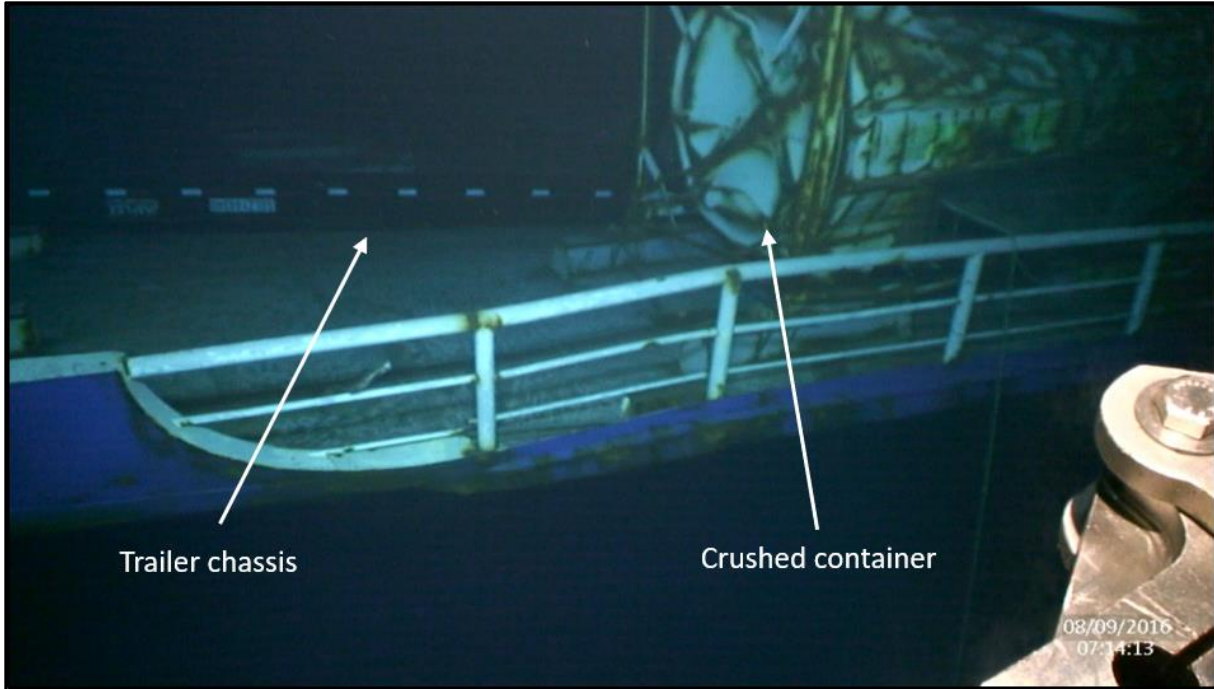
**Figure 34.** Crushed tank container in bay 2, starboard side. (Image from mission 3)

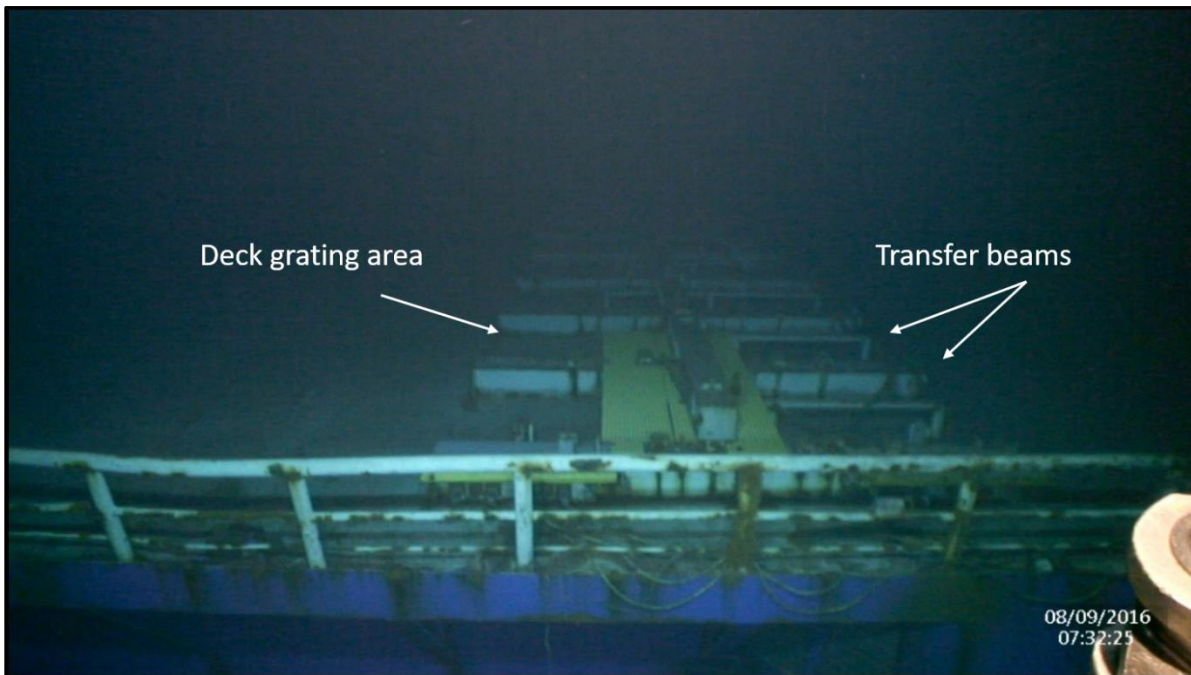
**Figure 35.** Fiberglass deck grating missing from container support beams, port side, with intact transfer beams. (Image from mission 3)

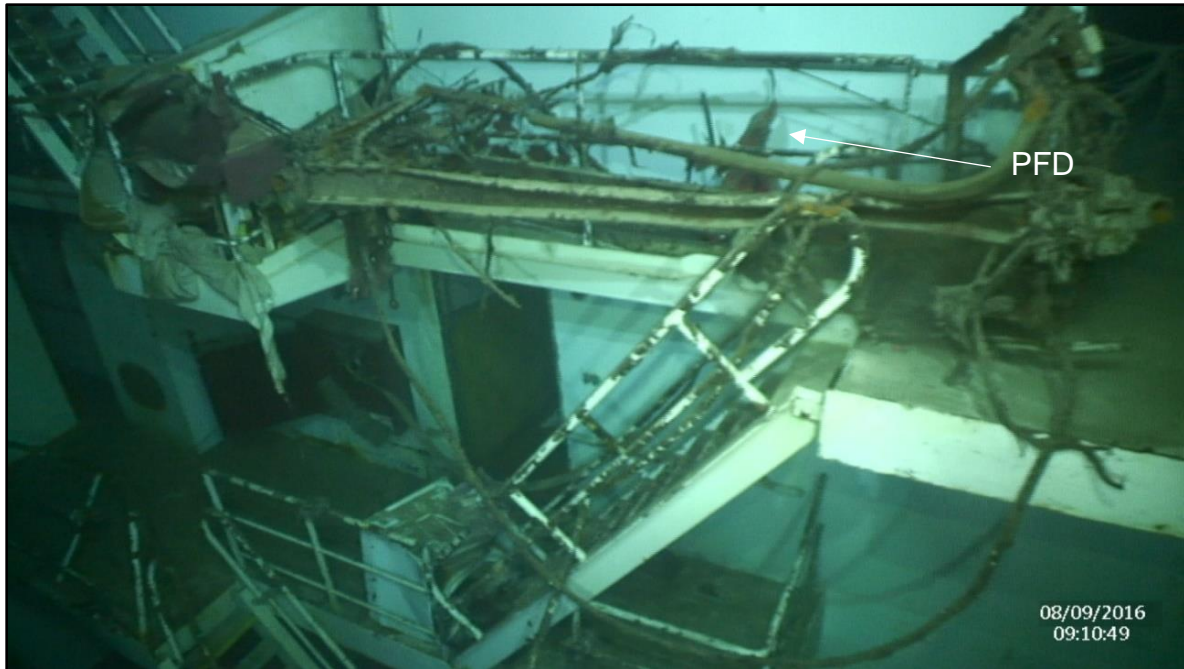
**Figure 36.** PFD entangled on boat deck walkway. (Image from mission 3)

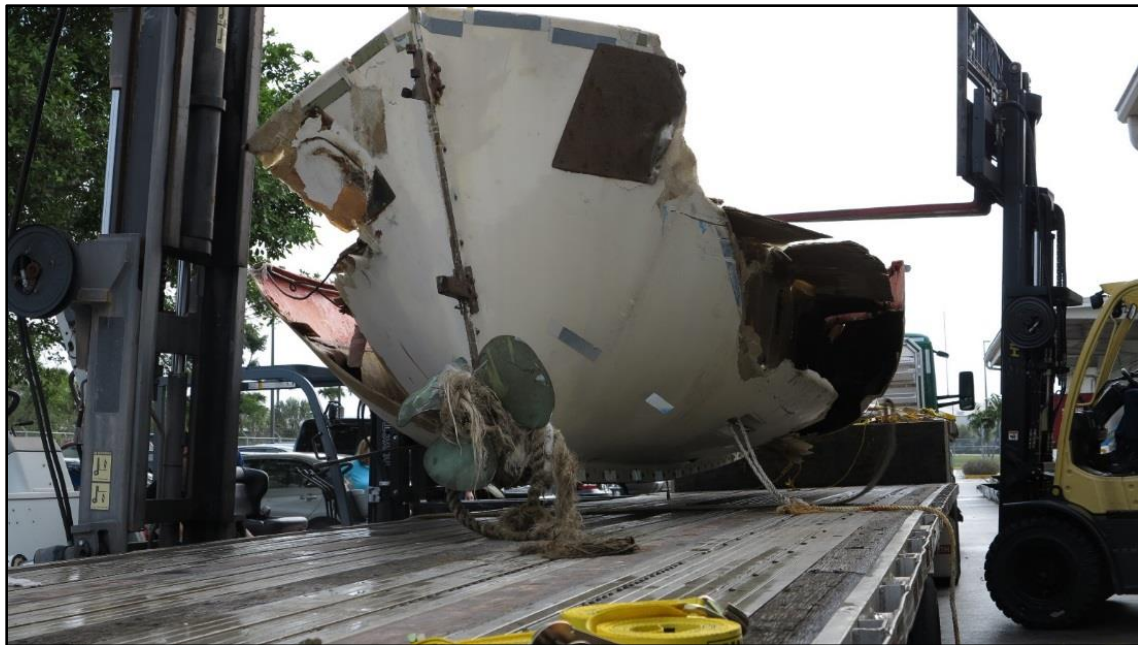
**Figure 53.** *El Faro's* starboard lifeboat on arrival at Coast Guard Air Station Miami. Note fouled propeller, bent propeller blade, and damage to port and starboard sides of hull.

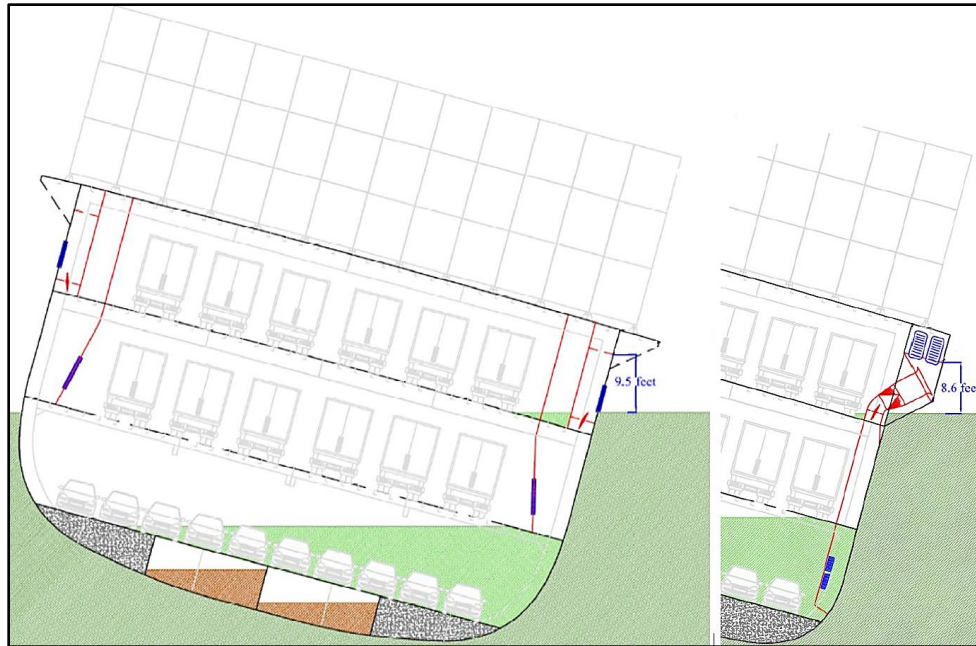
**Figure 59.** Ventilation supply trunk (right) and aft exhaust trunk (left) in hold 3, with flooding of hold to 20 percent (0.7 permeability) and heel angle of 15°. (Adapted from figure 6-18 in MSC 2017)

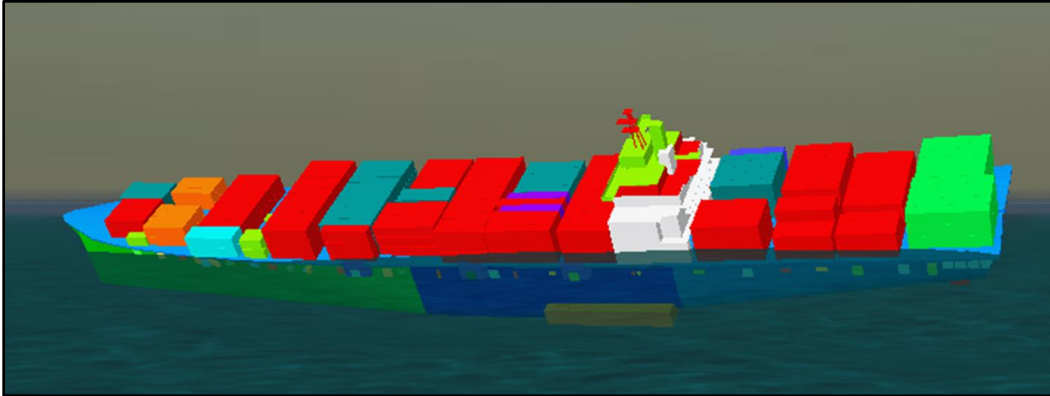
**Figure 61.** *El Faro* rolling about a 15° to 18° static heel with waves or green water reaching ventilation openings after propulsion loss. (Screen shot at extreme position from CSRA video simulation)

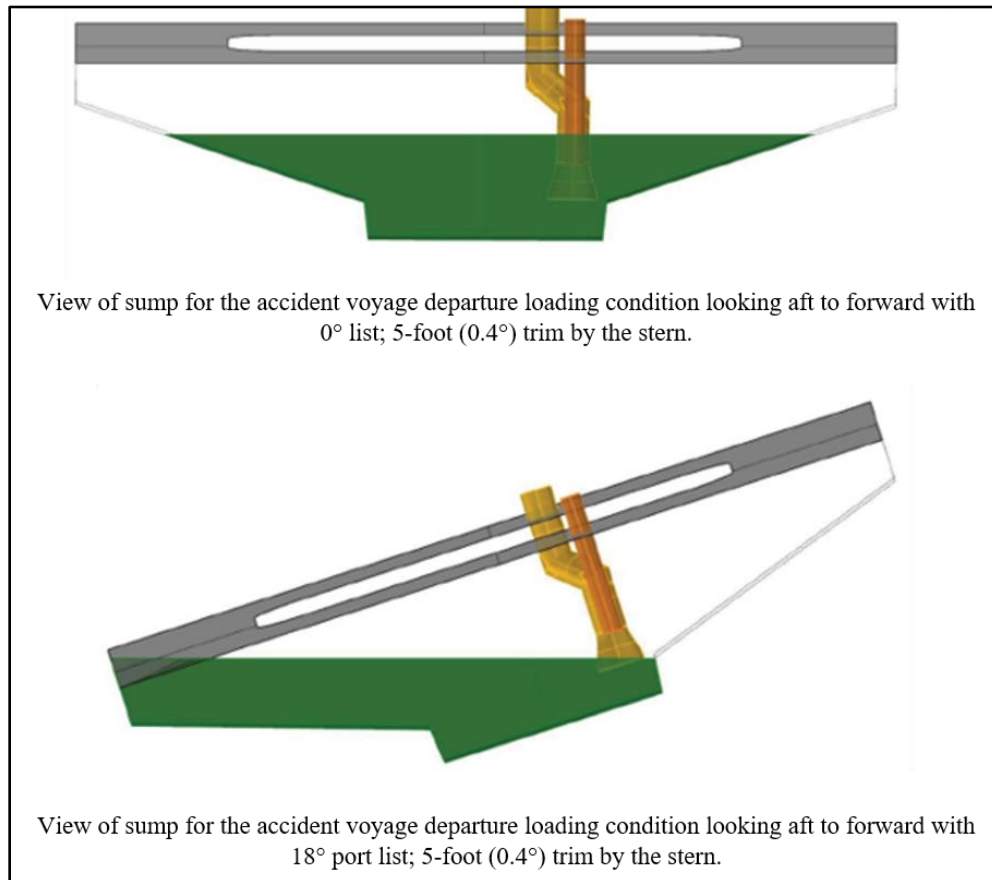
**Figure 64.** Effect of  $18^\circ$  port list on lube oil system with oil level at 26 inches. (Graphic by Coast Guard Marine Safety Center, modified by NTSB)

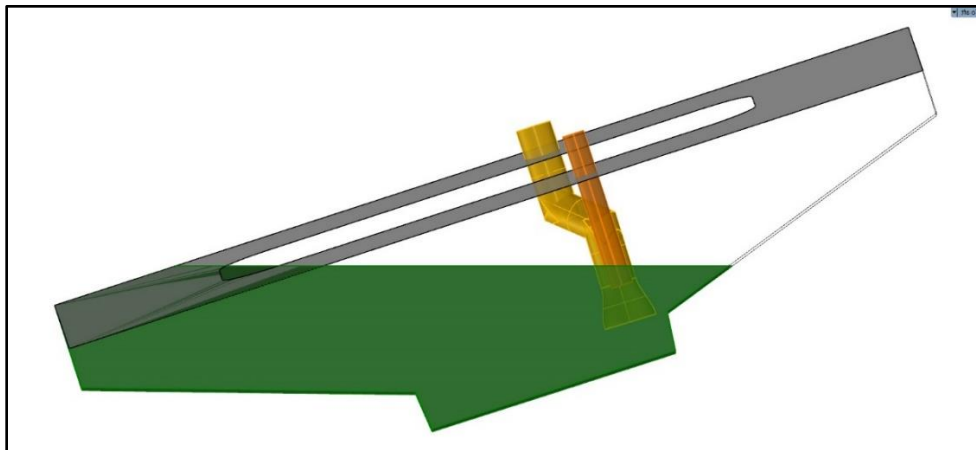
**Figure 65.** Effect of 18° port list on lube oil system for main engine with 32 inches of lube oil in sump, looking from aft to forward. (Graphic by Coast Guard Marine Safety Center, modified by NTSB)
