Sinking of US Cargo Vessel SS *El Faro*  
Atlantic Ocean, Northeast of Acklins and Crooked Island,  
Bahamas  
October 1, 2015

**Accident Report**

NTSB/MAR-17/01  
PB2018-100342

# Marine Accident Report

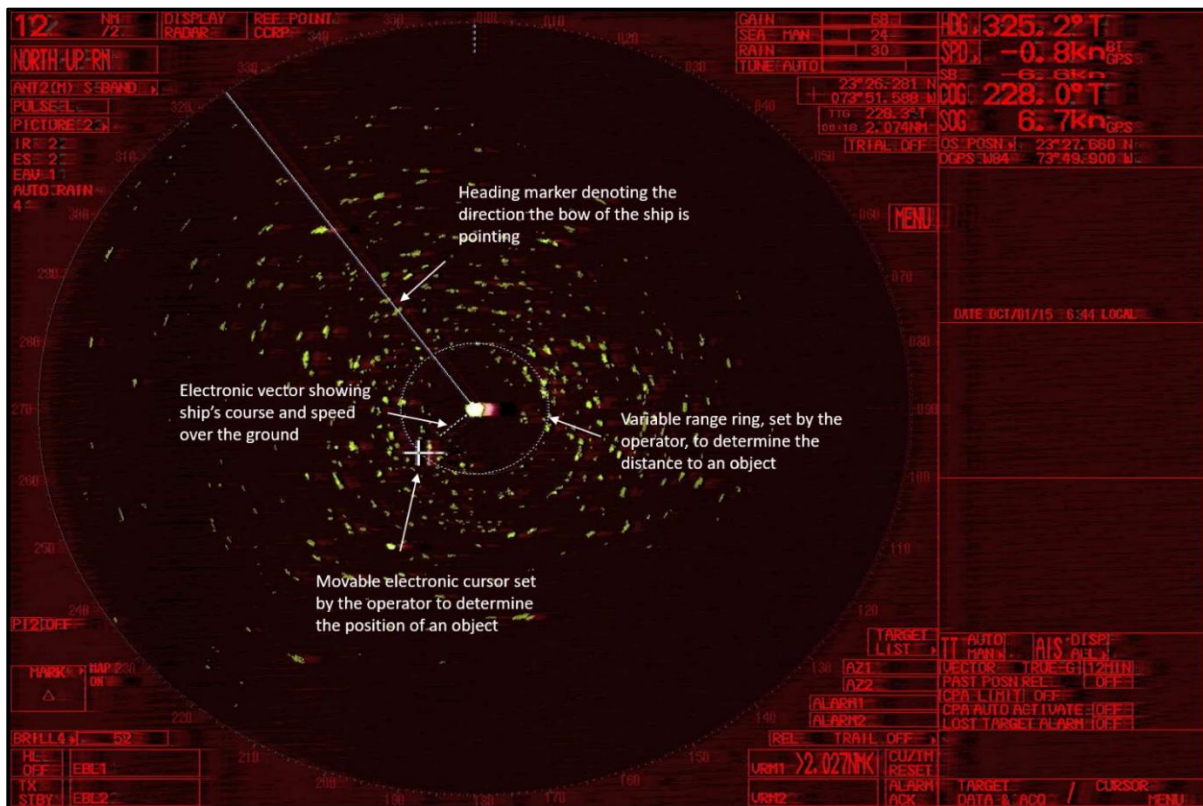
At 0644, the captain told the AB on watch, “You got some turns right now,” meaning that propulsion seemed to have returned. The radar image in figure 8, obtained from the VDR, shows that *El Faro*’s bow was headed northwest but that the ship was actually traveling southwest, at a speed (in relation to the ground) of 6.7 knots—that is, it was being pushed sideways by the wind and waves, nearly perpendicular to its original course before losing propulsion.

**Figure 8.** Radar image from 0644 on October 1 showing *El Faro* heading (bow direction) northwest (325.2°) but moving southwest (228°).

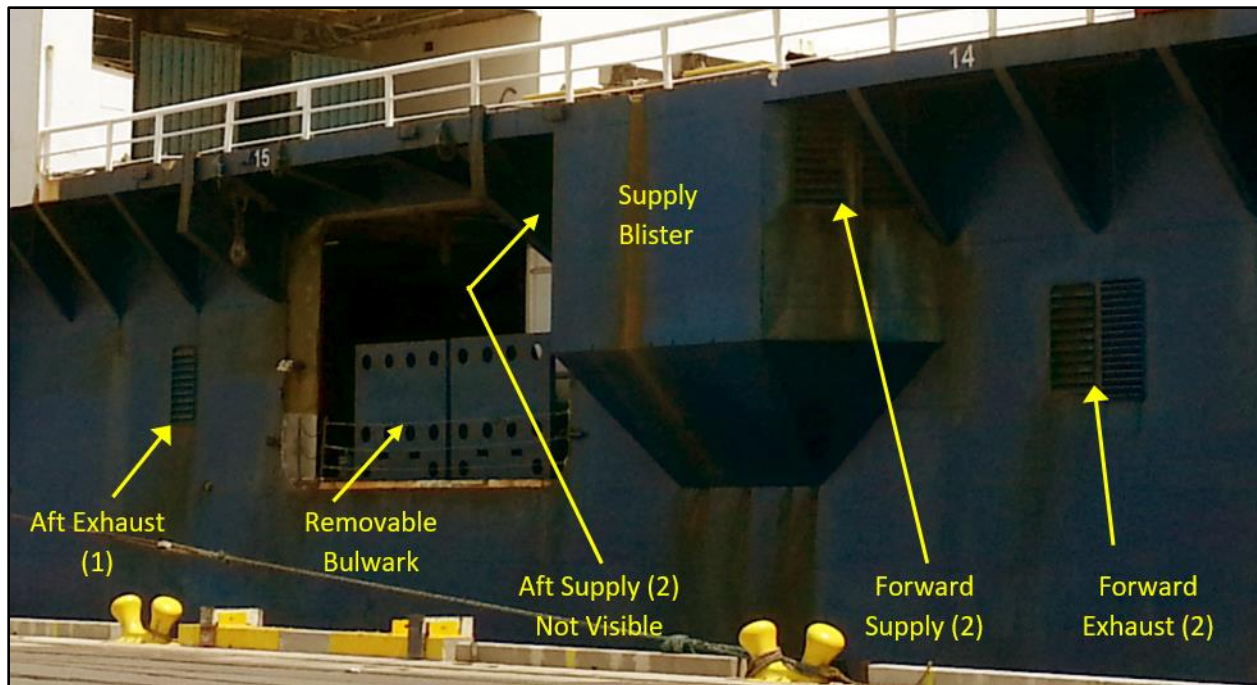
**Figure 10.** Starboard side of *El Faro* showing supply and exhaust ventilation openings to cargo hold 3. (Photo by Herbert Engineering)

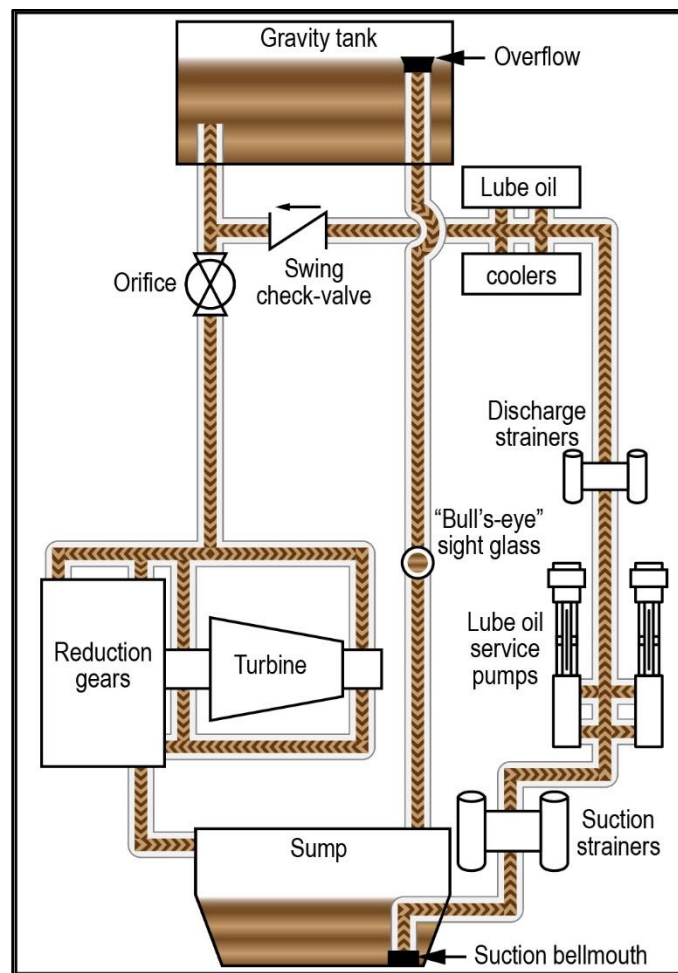
**Lubricating Oil.** According to the 1973 ABS rules for building and classing steel vessels, the lubricating oil system of the main engine was "to be so arranged that it will function satisfactorily when the vessel is permanently inclined to an angle of 15 degrees athwartship and 5 degrees fore and aft." The Coast Guard had no rules for main engine or lube oil operation angles when the vessel was built (or when it was lengthened in 1993). *El Faro's* lubricating oil system is diagrammed in figure 11. Because the suction for the lubricating oil service pump was located in the starboard, aft section of the sump, a port list with a forward trim would be the worst-case scenario for exposing the suction bellmouth, which could result in a loss of lubricating oil to the main engine.

**Figure 11.** Schematic of *El Faro's* lubricating oil system, showing component parts and direction of oil flow.

The VDR recorded no conversations from the engine room, so it is unknown what actions the crew took to counter the problem with the lubrication oil levels (which were not captured electronically) or what the problem actually was. The mostly likely scenario, however, is that the vessel's sustained list to port caused the lubrication oil in the main engine sump to fall below the bellmouth of the suction pipe leading to the pumps (refer to figure 11, section 1.3.6).

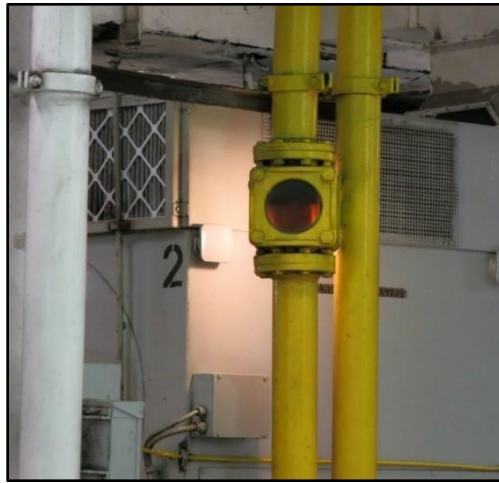
From the engine room, overflowing oil, indicating proper operation of the lube oil service pumps, could be monitored through an illuminated port (“bull’s-eye”) in the supply line that returned oil to the sump (figure 12). An engineer who had served aboard TOTE’s *Ponce*-class vessels (last in 2012) told the third marine board that in rough weather, flow in the bull’s-eye might be interrupted by sloshing oil in the gravity tank. In the event of a pressure loss, about 8 minutes

**Figure 12.** Bull's-eye for monitoring lube oil flow from gravity tank. (Photo from *El Yunque*)

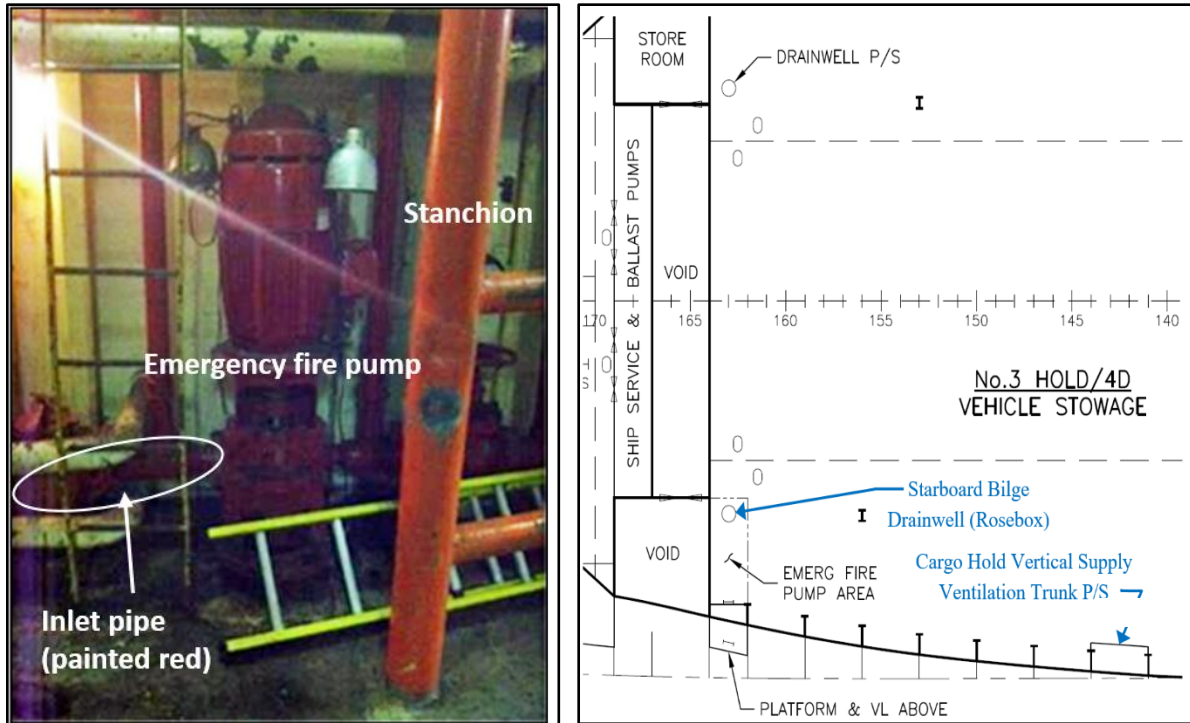
**Fire Main.** The fire main system consisted of a combination pump, called a bilge, fire, and general service pump, located on the starboard side of the lower engine room. The pump was a Worthington vertical, centrifugal model rated for 575 gpm at 125 psig. An emergency fire pump, rated for 635 gpm at 125 psig, was located on the starboard side of cargo hold 3, on the tanktop. The pump had its own sea suction (seawater inlet pipe) directly outboard of the pump. As seen in figure 13, the fire pump (shown in the photo) was protected by at least one vertical steel stanchion, and a platform (shown in the drawing) was located above the pump, with a vertical ladder installed nearby.

**Figure 13.** Emergency fire pump. Photo shows emergency fire pump (center rear) in *El Faro*'s hold 3 (photo by Maine Maritime Academy cadet). Diagram, from general arrangement drawing, shows emergency fire pump location in hold 3, fourth deck (VL = vertical ladder).

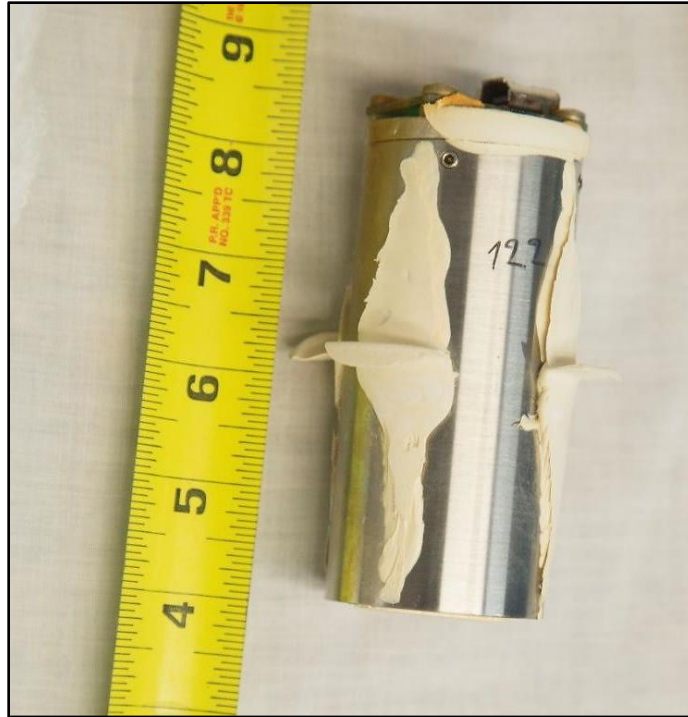
The VDR data were stored on a flash memory chip inside a protective capsule. On August 8, 2016, after the capsule was recovered from *El Faro*'s wreckage, it was submerged in a bath of distilled water aboard the Navy vessel *Apache*, then disassembled and inspected for possible damage to the internal recording medium. Inside the capsule, layers of protective materials housed an inner capsule containing the circuit board assembly that stored the nonvolatile memory (figure 16).<sup>82</sup> The circuit board assembly was inspected for visible signs of damage or corrosion (figure 17) before being transported to the NTSB laboratory in Washington, DC, on August 12.

**Figure 16.** Inner VDR capsule assembly after removal from outer capsule.

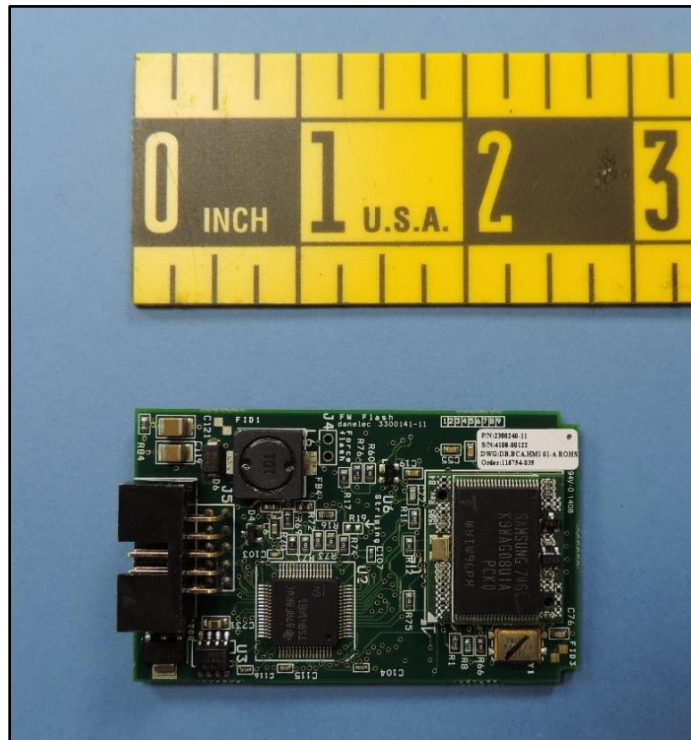
**Figure 17.** Circuit board assembly from inner VDR capsule.

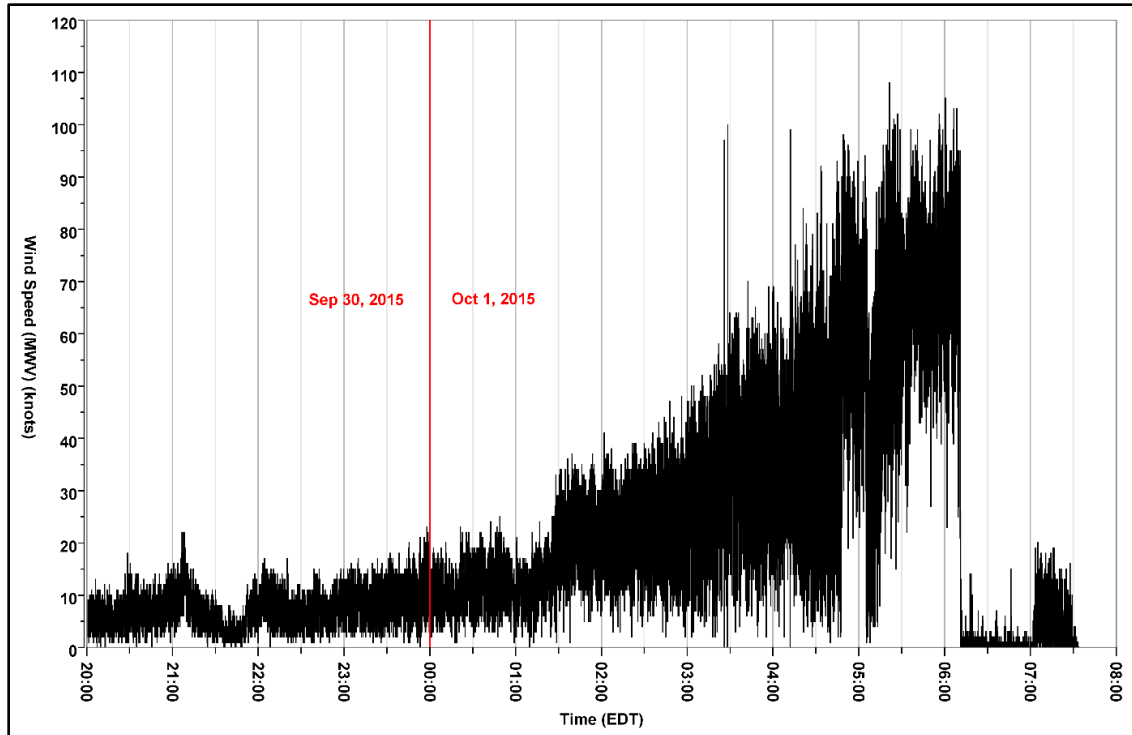
The vessel's anemometer displayed wind data on the bridge. Wind speed and direction were recorded by the VDR.<sup>91</sup> Figure 18 shows raw wind speed data captured by the VDR from 2000 on September 30 until the sinking. Throughout the VDR recording, however, over 99 percent of the anemometer data samples indicated a relative wind direction of between 180° and 193°. On the VDR recording, *El Faro*'s captain, chief mate, and second mate questioned the reliability of the wind speed and stated that the wind direction was "not good" and that "we don't have (any) anemometer."

**Figure 18.** Raw VDR wind speed data, from 2000 September 30 to data loss.

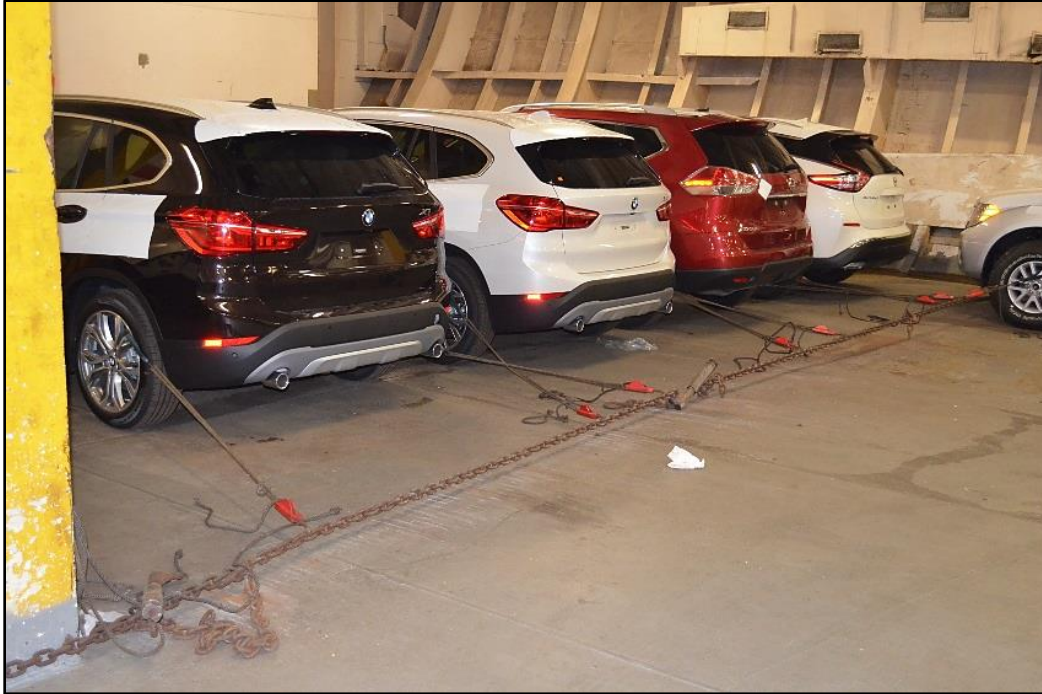
Automobiles, considered semistandardized cargo, were to be lashed using portable securing devices consisting of fiber rope or nylon strapping attached to steel tensioners that were fitted with hooks at both ends. Four lashings were to be run, one from each corner of a vehicle, to the fixed D-rings or cloverleaves on the deck (figure 21). A variation of that securing arrangement, not included in the cargo-securing manual, was to run lashings from the four corners of the automobile to a long chain. The long chain ran across the width of the ship and was secured to D-rings at either end. Some of the chains passed through a D-ring before being secured to additional D-rings at each end. A lashing variation observed on *El Yunque* in October 2015 is shown in figure 22. One of the longshoremen who had lashed the automobiles on *El Faro* before the accident voyage testified when shown a photo of the lashings on *El Yunque* that they had used that arrangement on *El Faro*.

**Figure 22.** Two automobiles lashed to one length of chain. (Photo from hold 5 of *El Yunque*)

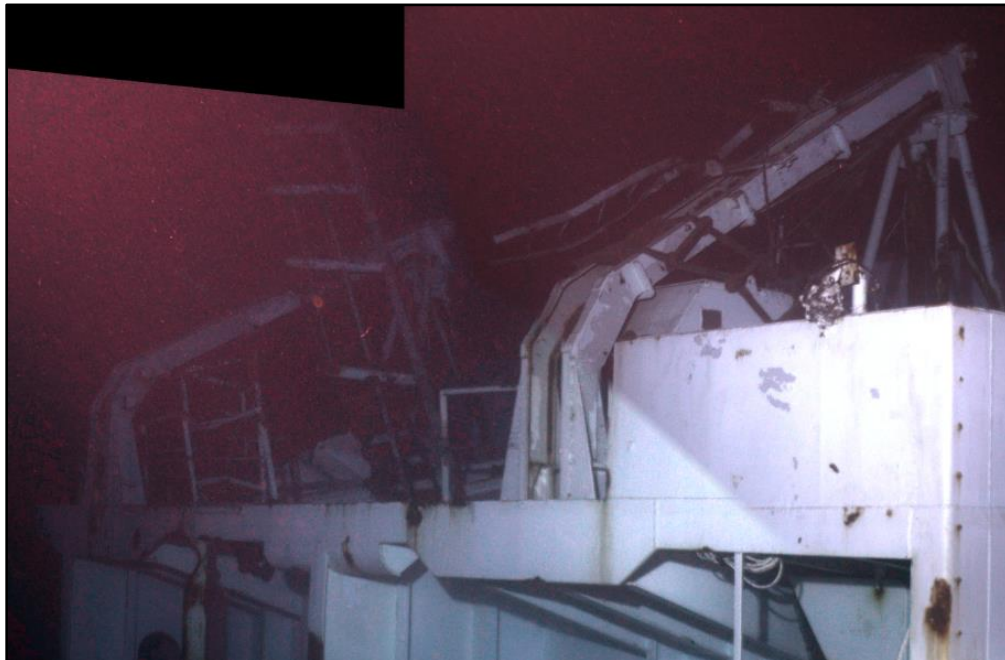
The gravity davits (cranelike devices for lowering boats into the water) for the starboard lifeboat were discovered intact during the second mission (figure 25). The arm for the forward davit was displaced and resting on the deck, but the arm's cable was still attached to the track. The gravity davits for the port lifeboat showed greater damage, with the aft track and davit broken and hanging (figure 26).

**Figure 25.** Intact gravity davits for starboard lifeboat, with forward davit in foreground. (Photomosaic image from mission 2)

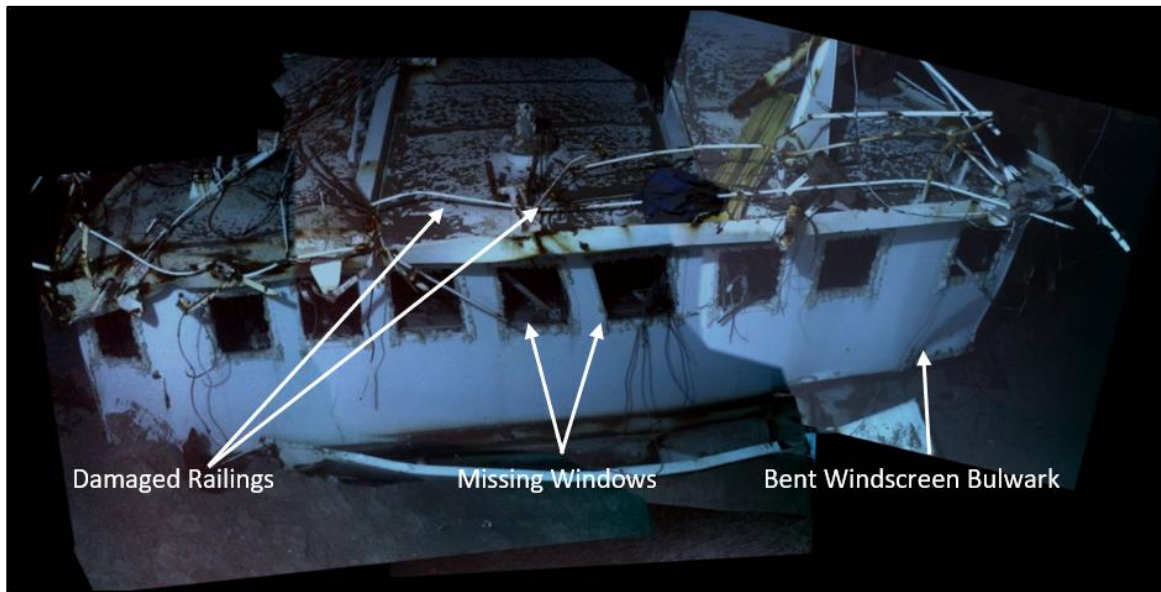
The navigation bridge and bridge deck that had been discovered during the first mission were further explored during mission 2. The photomosaic image in figure 27 shows that all windows on the forward side of the bridge were missing; that the windscreen bulwark was bent forward; and that the top railings were missing, severely bent, or broken. The starboard forward corner of the wreckage had settled deeper into the seabed than the other corners.

**Figure 27.** Bridge and bridge deck, looking aft. (Photomosaic image from mission 2)

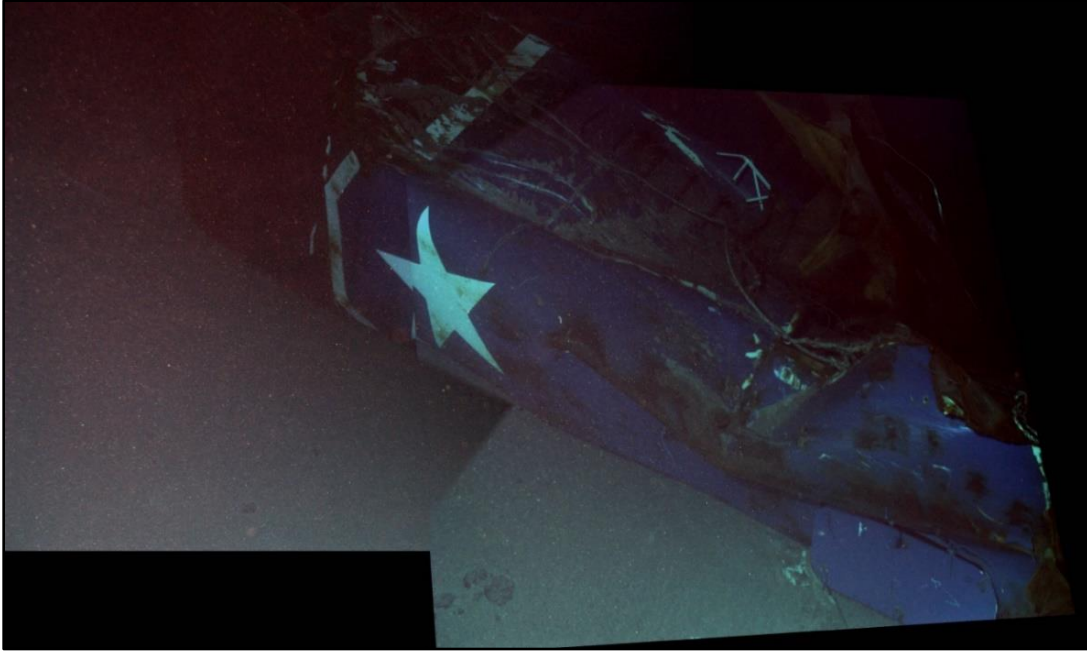
*El Faro*'s exhaust stack was discovered during the second mission about 2,625 feet (0.43 nm) north of the main hull (figure 28). It was largely intact, though the forward face was missing its steel plating and the stack was scratched, dented, and deflected inward. The boiler uptake funnel was missing from the top of the stack.

**Figure 28.** Exhaust stack lying on seafloor, Sea Star (company) symbol clearly visible. (Photomosaic image from mission 2)

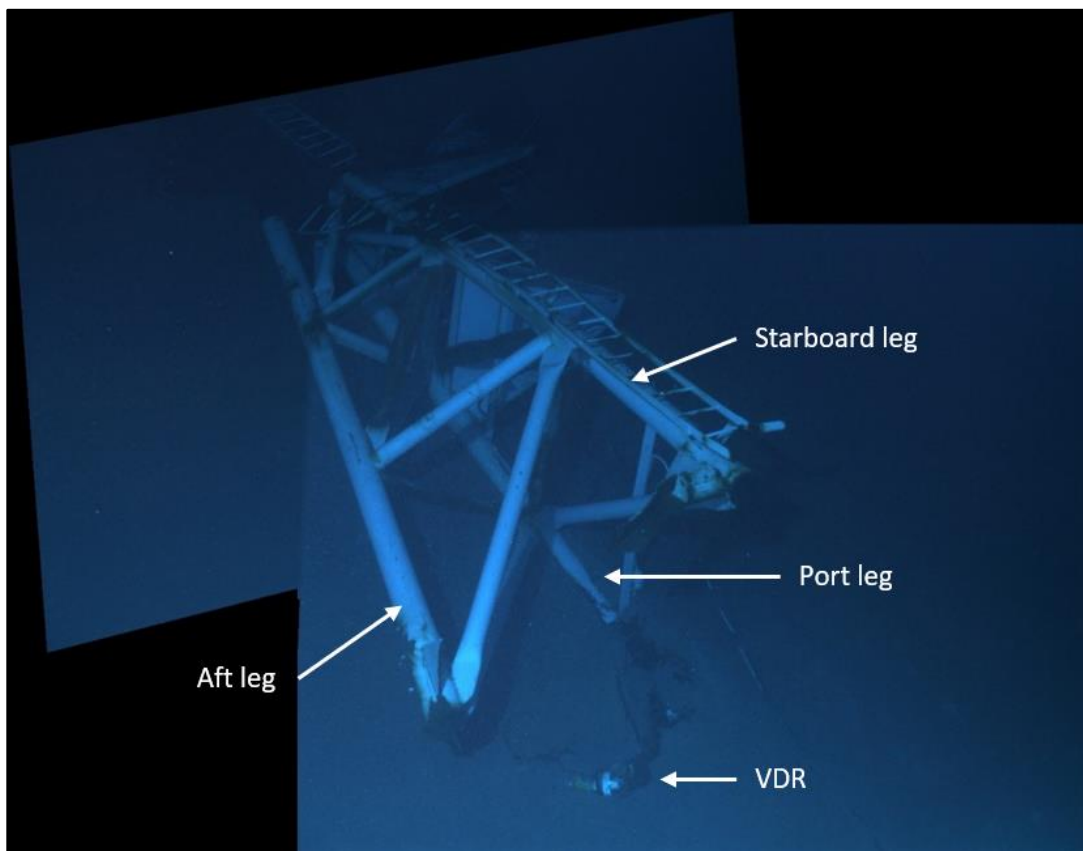
The tripod mast and VDR capsule were discovered on the seafloor about 1,640 feet (0.28 nm) north of the main hull (figure 29). The large structural members were intact, but the overall structure was bent aft. The VDR was attached to the port leg and buried in mud.

**Figure 29.** Mast and VDR capsule on seafloor. (Photomosaic image from mission 2)

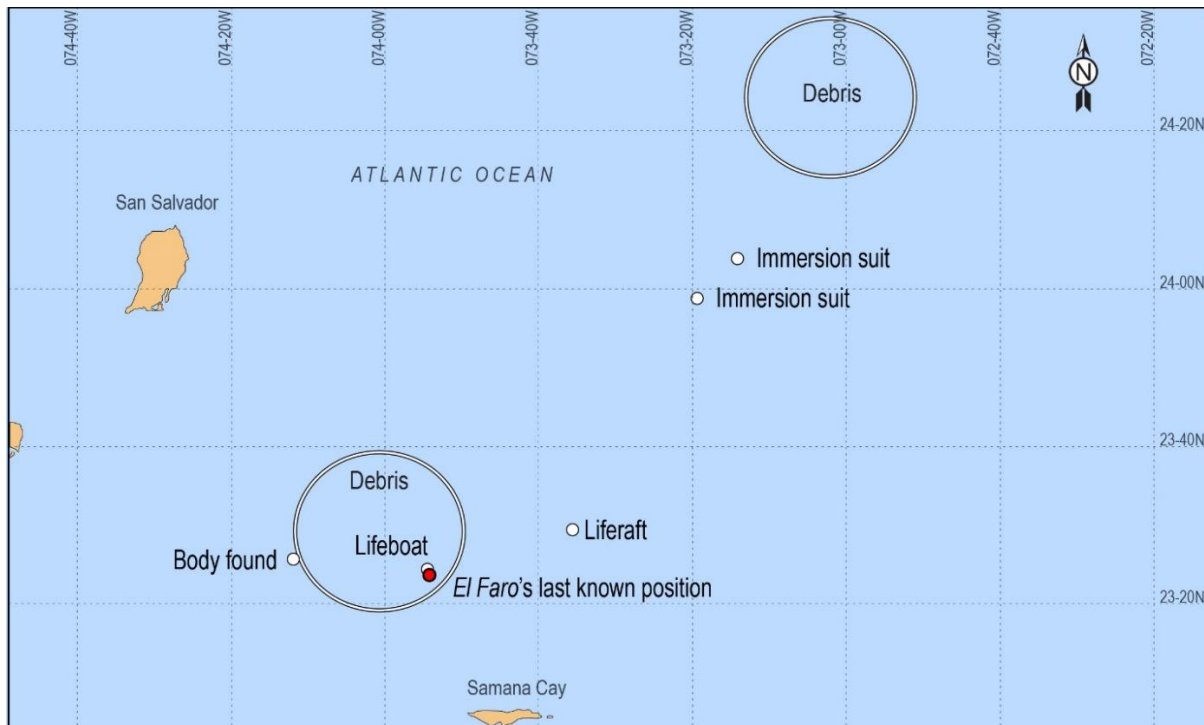
Also on October 3, a Coast Guard HC-130 aircraft located a debris field 120 nm northeast of Crooked Island. A Coast Guard MH-60 helicopter relocated the debris field and found three liferings, one of which was stenciled "El Faro." The helicopter located a second debris field 90 nm northeast of Crooked Island, consisting of small unidentified objects believed to be packing material. Three cutters, the *Northland*, the *Resolute*, and the *Charles Sexton*, were en route to the search area as weather and seas permitted.

The Navy P-8 reported two liferafts in separate locations. At 1806, the cutter *Northland* found one of the liferafts at 23.4866N, 073.5883W, about 18 nm northeast of *El Faro*'s last known position. The ship's rescue swimmer searched the partially inflated liferaft for any sign of survivors.<sup>146</sup> Finding no one on board, the *Northland* sank the liferaft, to prevent its rediscovery and an ensuing duplicate search for survivors or remains, and proceeded to the position of the second liferaft. The Coast Guard later determined that the second reported liferaft was actually the starboard lifeboat.

**Figure 47.** Two debris fields located during search-and-rescue operations and *El Faro*'s last known position from VDR data. Distance between debris fields was about 77 nm. Degrees of latitude are 60 nm apart. Distance between degrees of longitude varies with distance from equator, where it is about 60 nm. (Adapted from Coast Guard graphic)

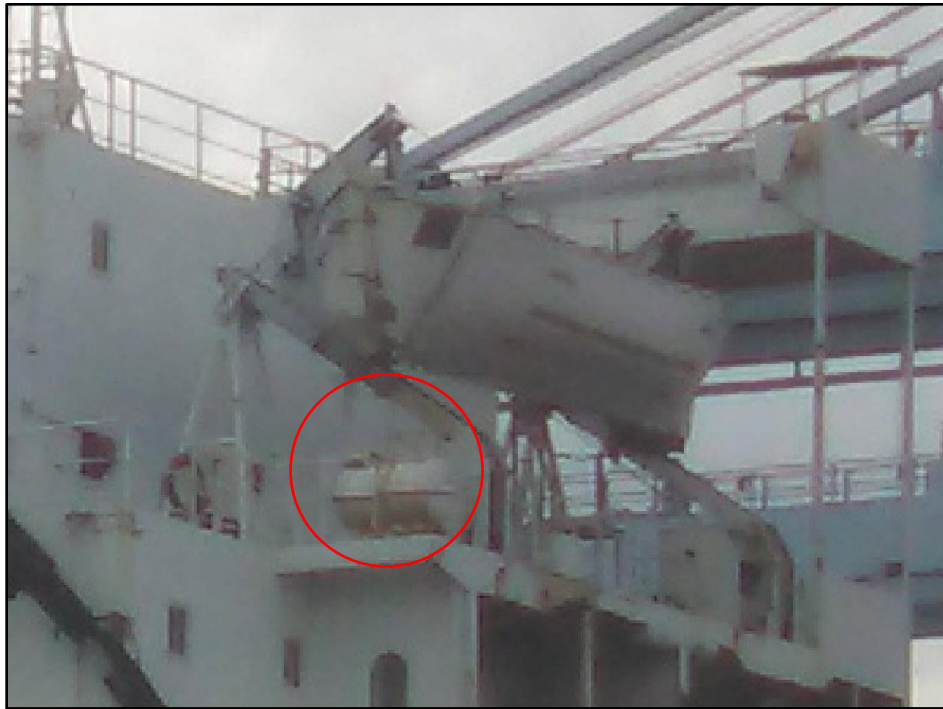
**Figure 49.** Location of liferaft stowed below *El Faro*'s starboard lifeboat. (Photo by Maine Maritime Academy cadet, summer 2015)

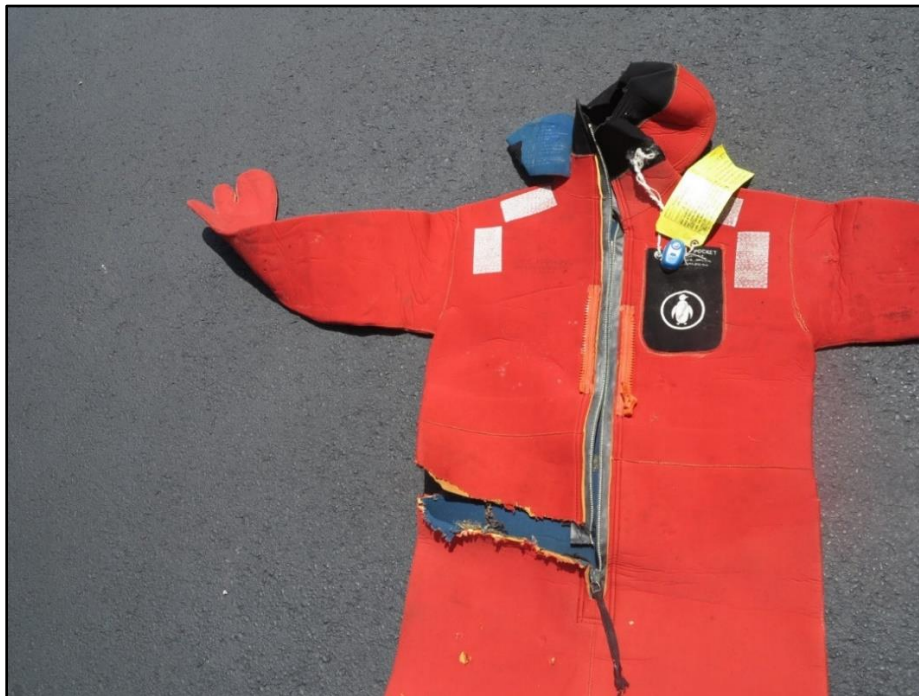
The cutter *Charles Sexton* recovered two of *El Faro*'s immersion suits after the accident. The first suit was recovered on October 6. The back was marked "S.S. El Faro San Juan, P.R." in white but appeared to have been previously marked "El Morro" in black. The second immersion suit (figure 54) was recovered on October 7. It was found with whistle and strobe light (turned off but operational); unzipped, left arm inside out, torn almost in half at right hip seam; and back marked "S.S. El Faro San Juan, P.R." in white but appeared to have been previously marked "El Morro" in black. As noted earlier, an immersion suit containing human remains was located but could not be recovered.

**Figure 54.** Immersion suit recovered on October 7, 2015.

According to maintenance records for June 2015, the recovered immersion suits were spare immersion suits Nos. 48 and 50. Both were last inspected and pressure-tested in July 2013 by Liferrafts Inc., of Puerto Rico, and each had a light with an expiration date of April 2016.

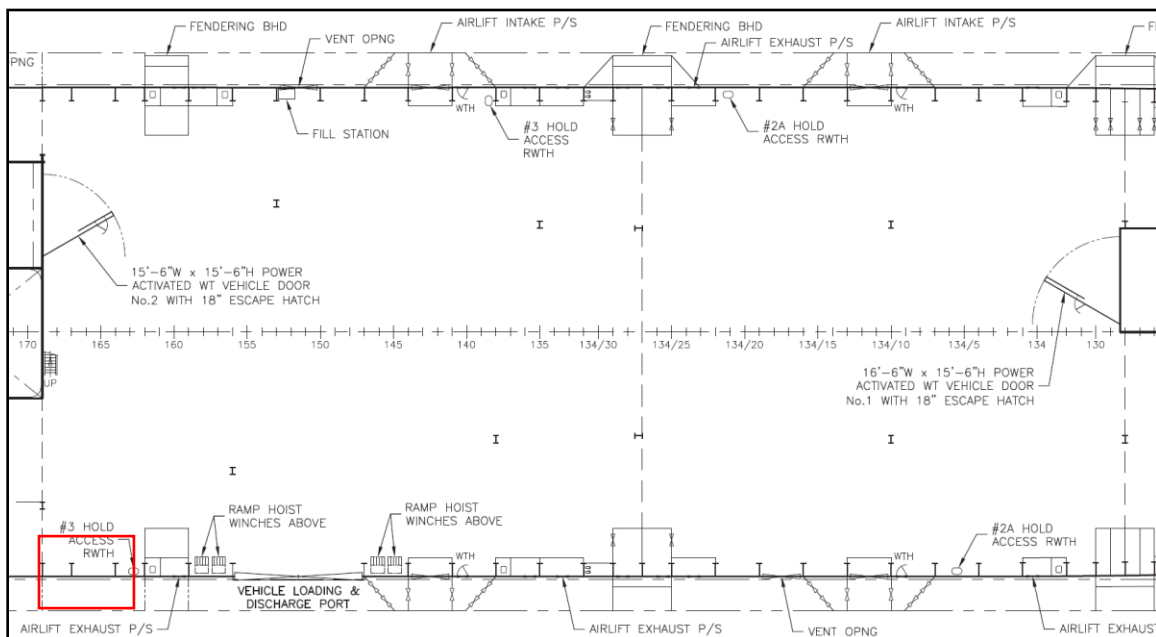
The VDR recording indicates that the vertical-access scuttle on the starboard side of the second deck that led to hold 3 was open during the accident. General arrangement drawings (such as figure 56) show that the second deck had two scuttles (called RWTHs [raised watertight hatches] on the drawings), through the second deck to hold 3, at frame 163 on the starboard side and at frame 138.5 on the port side. Hold 2A also had two such accesses. Figures 57 and 58 show the scuttle on the starboard side of the second deck to hold 3 and the scuttle on the port side to hold 2A.

**Figure 56.** Second deck plan showing scuttles. (Starboard scuttle to hold 3 outlined in red)

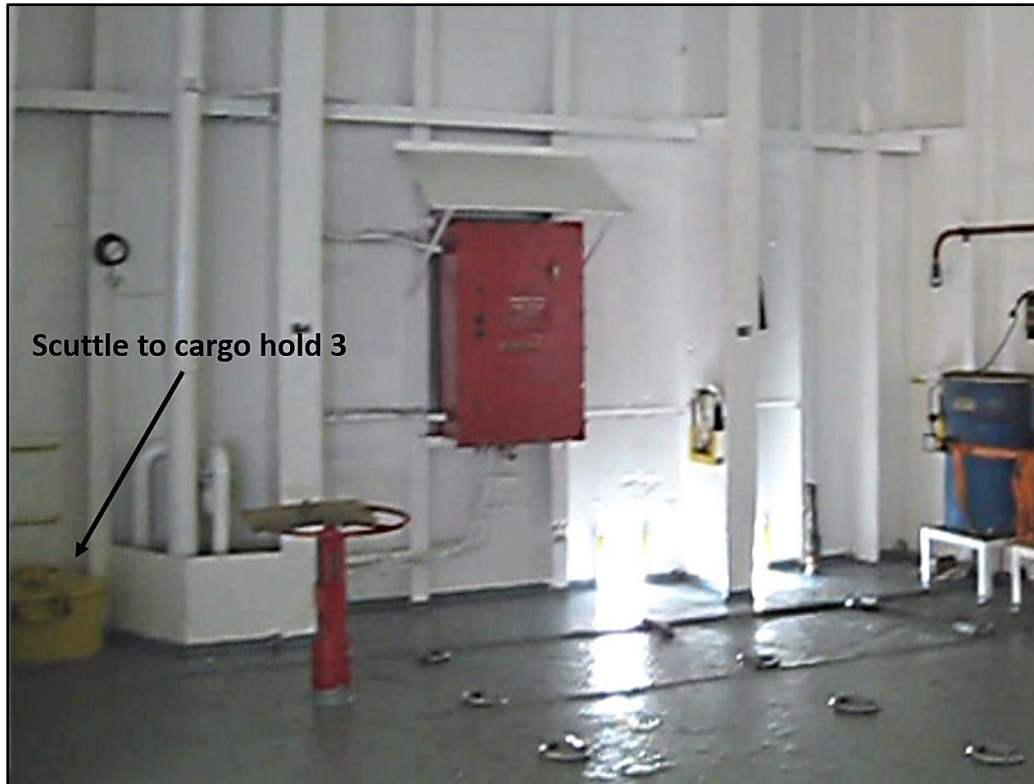
To achieve watertight integrity, a scuttle was secured by closing the steel cover (which had a gasket) and turning a wheel. Through a linkage system, the wheel moved four steel pegs (dogs) to seal the scuttle tight and prevent water from entering the hold. A former *El Faro* boatswain testified that a person could not tell by looking at a closed scuttle whether the wheel had been turned to engage the dogs and seal the hatch. A past chief mate and captain of *El Faro* stated, "You would have to grab the handle of it and see if it was locked or unlocked."

**Figure 57.** Second deck scuttle to hold 3. (Photo by former *El Faro* second mate)

The steel plates or covers to the scuttles were characterized by crew and officers as being heavy and hard to open. A former *El Faro* chief mate and captain stated that he had “never seen one pop open on its own.” Another former captain of *El Faro*, who had nearly 27 years’ experience as captain or chief mate on that ship and other vessels of the *Ponce* class, stated, “I don’t see a wave getting in there and lifting [a scuttle]. Even if it was not dogged.”

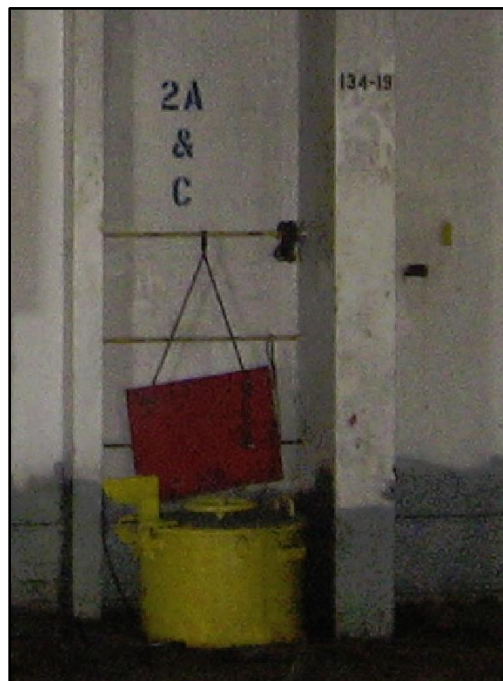
**Figure 58.** Second deck scuttle to hold 2A, similar to hold 3 scuttle. (Photo by Herbert Engineering)

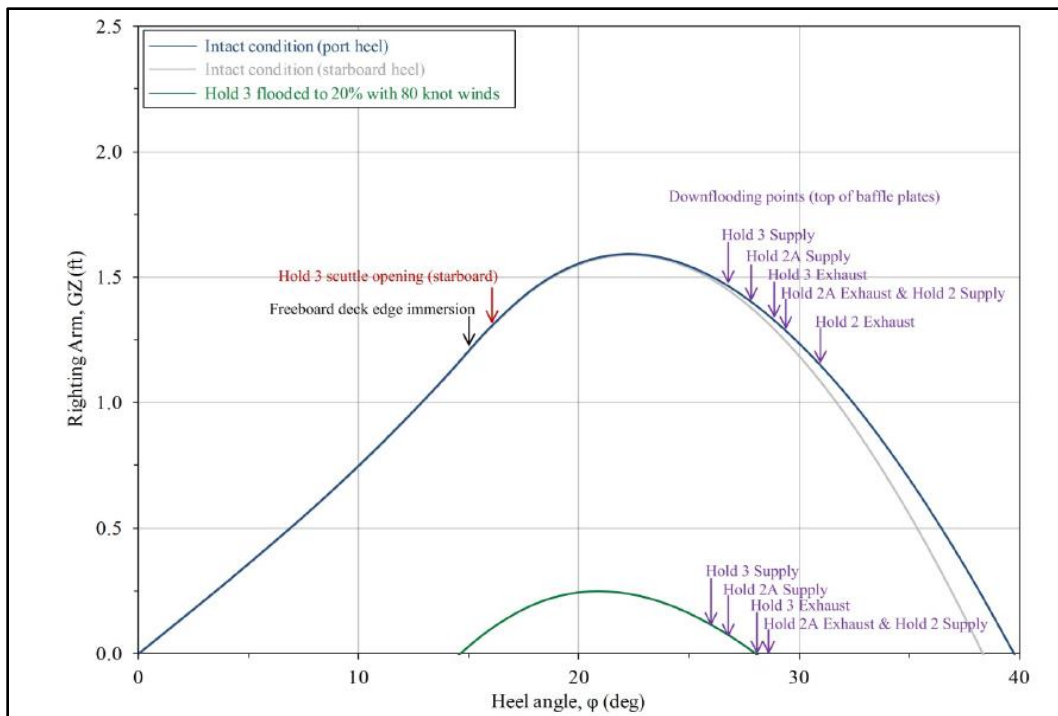
- Hold 3, starboard access scuttle: 16.2° (intact condition), 14.9° (hold 3 flooded to 20 percent).
- Hold 2, vent supply baffle: 29.6° (intact), 28.9° (hold 3 flooded).
- Hold 2, aft and forward exhaust vent baffles: at least 30° in either condition.
- Hold 2A, vent supply baffle: 27.7° (intact), 26.9° (hold 3 flooded).
- Hold 2A, aft vent exhaust baffle: 29.8° (intact), 28.9° (hold 3 flooded).
- Hold 2A, forward vent exhaust baffle: 30.3° (intact), 29.4° (hold 3 flooded).
- Hold 3, vent supply baffle: 27.2° (intact), 26.3° (hold 3 flooded).
- Hold 3, aft vent exhaust baffle: 29.1° (intact), 28.1° (hold 3 flooded).
- Hold 3, forward vent exhaust baffle: 29.5° (intact), 28.6° (hold 3 flooded).
- The other three downflooding points, all in hold 1, required a heel angle of at least 42° to downflood in either condition.

Figure 60 shows the downflooding angles for the downflooding points described above, plus the angle at which the edge of the freeboard deck would have been immersed (about 15°). The downflooding angles are superimposed on two righting arm curves. The upper curve is the righting arm for *El Faro* in the intact condition on the morning of the sinking, before flooding began and with no wind. The lower curve is the righting arm for the vessel with hold 3 flooded to 20 percent and a sustained 80-knot beam wind. The smaller area under the lower righting arm curve, compared with the area under the upper curve, illustrates the severely reduced energy the vessel had available to right itself after hold 3 flooded and the ship lost power, with hurricane winds on its beam (blowing at a 90° angle to its starboard side).

**Figure 60.** Righting arm curves for *El Faro*, with annotated downflooding angles. Downflooding angles are indicated at various points on curves for convenience; they do not represent values used in righting-arm calculations. (Illustration by Coast Guard Marine Safety Center)

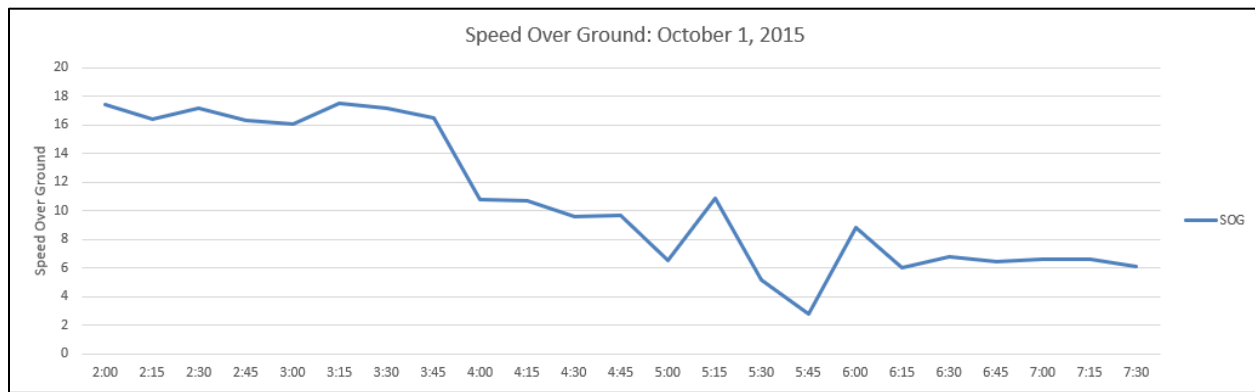
*El Faro* sank an hour and a half after it lost propulsion. From the time it left port the evening of September 29, the ship traveled at near-maximum speed, between 19 and 20 knots, for almost 30 hours. But it began to slow and develop a wind-driven starboard list when it came out of the protective lee of San Salvador Island about 0130 on October 1 and encountered the steadily increasing force of the wind. The ship's speed dropped quickly to 18 knots and fell more or less

steadily from then on, as shown in figure 62. (Engine speed, or propeller rpm, was not recorded by the vessel's VDR, but parametric data captured the ship's speed over ground.)

**Figure 62.** Ship's speed over ground from 0200 to 0730 on October 1.

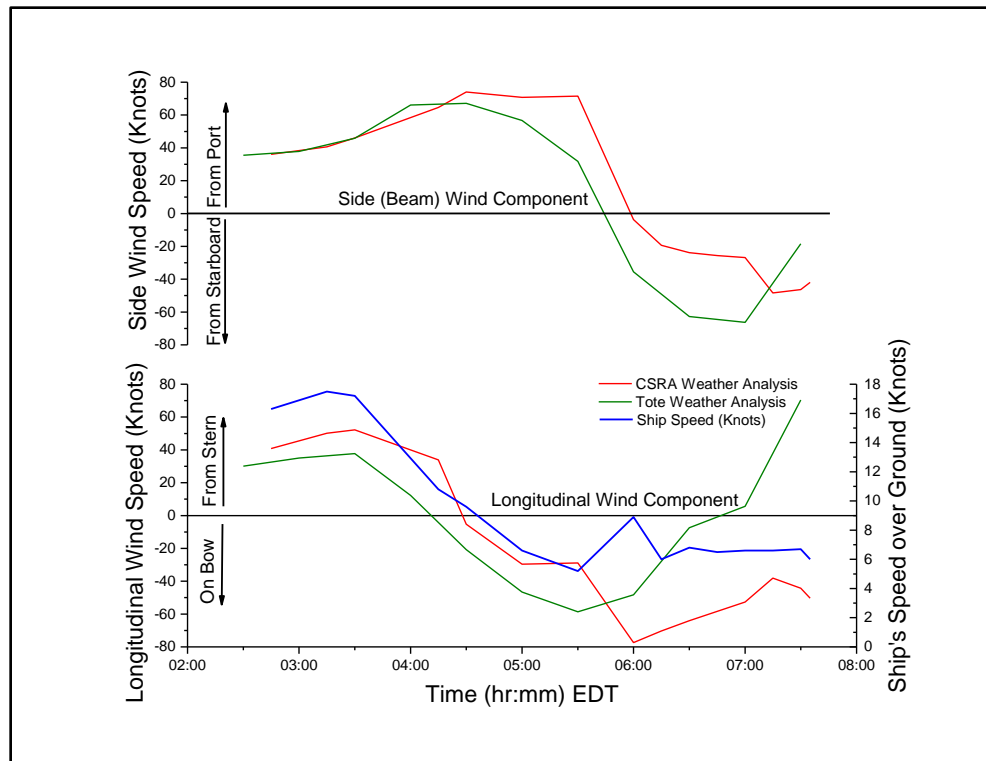
The graph in figure 63 demonstrates the relationship between ship's speed over ground and wind speed and direction, based on poststorm weather analyses. It shows that the increasing winds on the port side between 0400 and 0600 account for the vessel's starboard heel, while the shift of wind to the bow helps explain part of the vessel's slowing after 0400. The NTSB concludes that the initial list was caused by an increasing wind on the vessel's beam generated by Hurricane Joaquin.

About the time the watch changed, the crew began discussing that they were listing, or heeling, to starboard from the force of wind on the port side (windheel). By that point, the vessel's speed had dropped to less than 10 knots. The captain talked about shifting the water in the ballast (ramp) tanks to diminish the list. The vessel continued to make headway, though slowly, despite the sustained starboard list and the deteriorating weather.

**Figure 63.** Ship's speed over ground relative to wind direction. Wind directions obtained from NTSB-chartered dynamic analysis (by CSRA Inc.) and TOTE weather analysis submission.

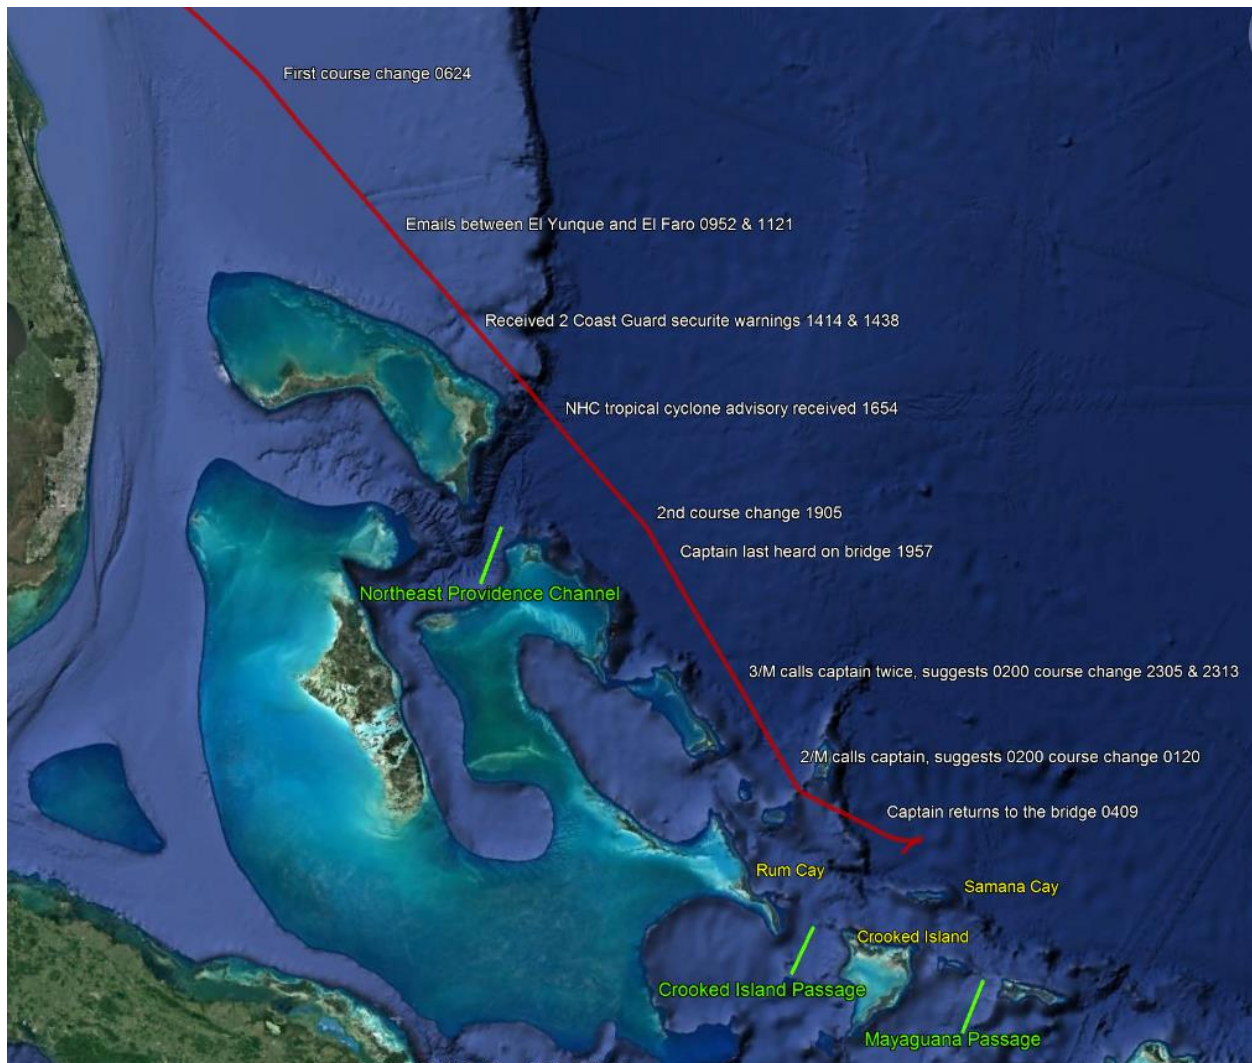
While the captain could have taken action at any time, there were several significant points along the accident route where the captain was provided with new information that gave him opportunities to adjust course and avoid heading into the storm (see figure 66). At 0624 on September 30, after reviewing the latest weather data from BVS, which showed the storm tracking west-southwest, the captain and chief mate decided to alter the vessel's path slightly southward. The captain described the course change as a "good little diversion" and suggested that Joaquin was not serious enough to warrant what the chief mate described as more "drastic" evasive action.

**Figure 66.** Significant opportunities for decision-making.

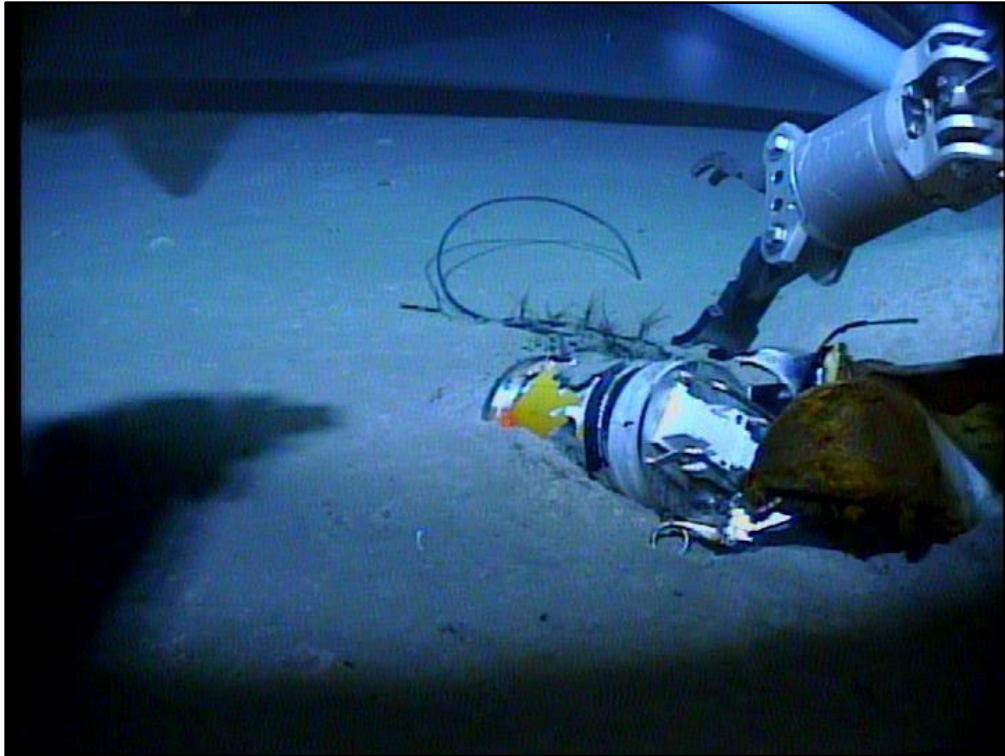
**Figure C-2.** CURV-21 freeing VDR capsule from seafloor. (US Navy photo)
