Sinking of US Cargo Vessel SS *El Faro*  
Atlantic Ocean, Northeast of Acklins and Crooked Island,  
Bahamas  
October 1, 2015

**Accident Report**

NTSB/MAR-17/01  
PB2018-100342

# Marine Accident Report

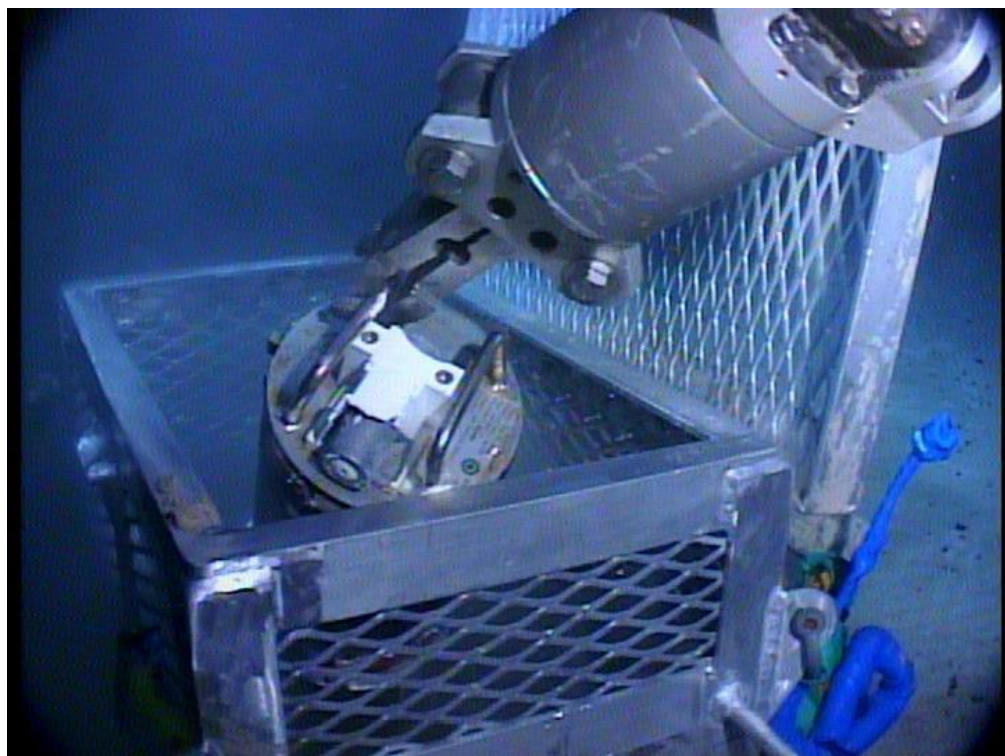
**Figure C-3.** CURV-21 placing VDR capsule in basket for transport to surface. (US Navy photo)

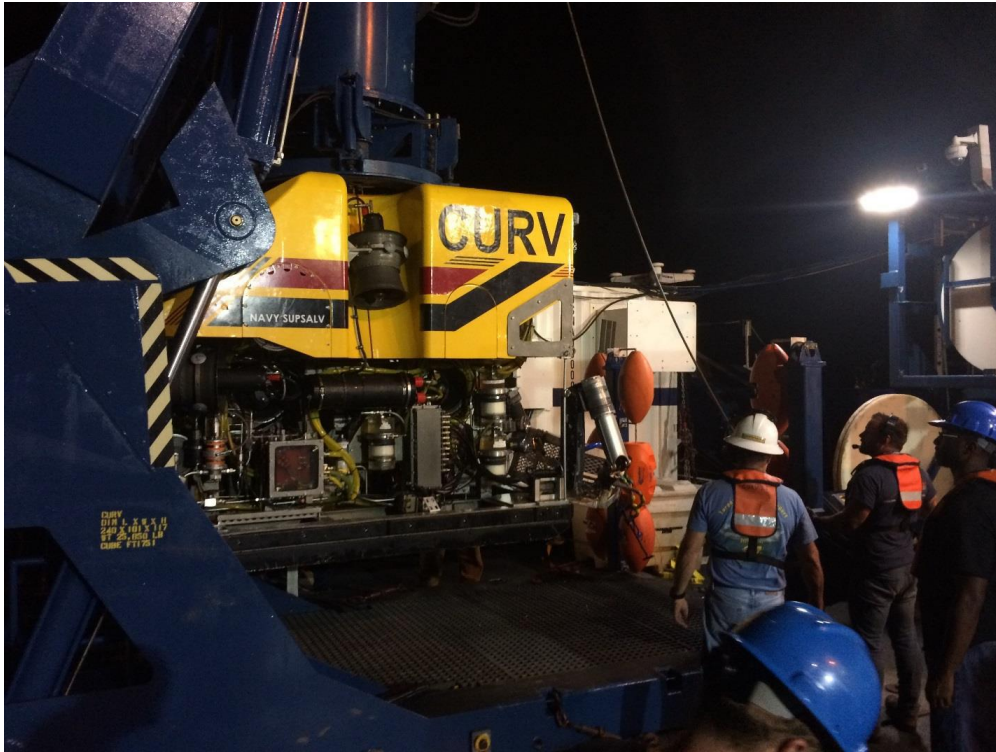
**Figure C-4.** CURV-21 landing on *Apache* deck after retrieving VDR.
